Retrofitting of the **HRC Office Battagram**

The building in Battagram that SDC selected as Housing Reconstruction Center (HRC) has been constructed 1950 in colonial style. The house has been partially damaged through the October 05 earthquake. The concrete lintels above windows and doors broke. In addition the center wall cracked seriously.

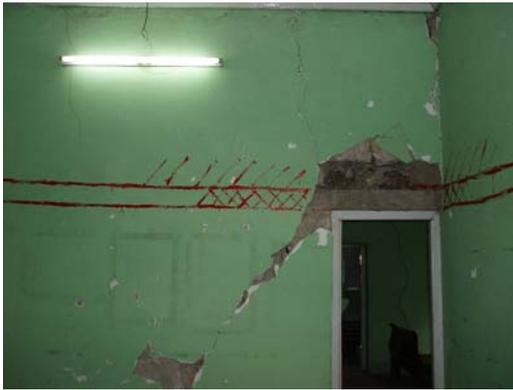
Major crack in center wall

Because of two door openings and two cupboard niches, the center wall was weak in its structure. Consequently the major earthquake damages are in that part of the building.

The whole center wall was build up new with a strenghtened lintel and without niches.

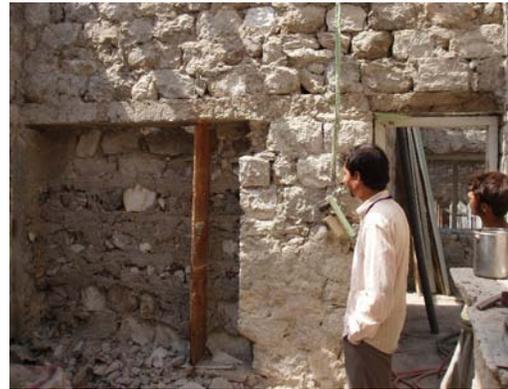
Cupboard niche in wall

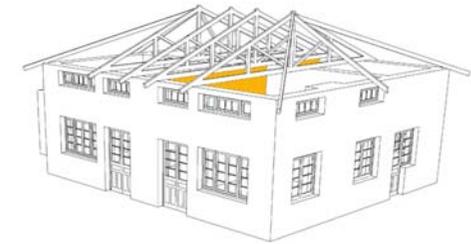
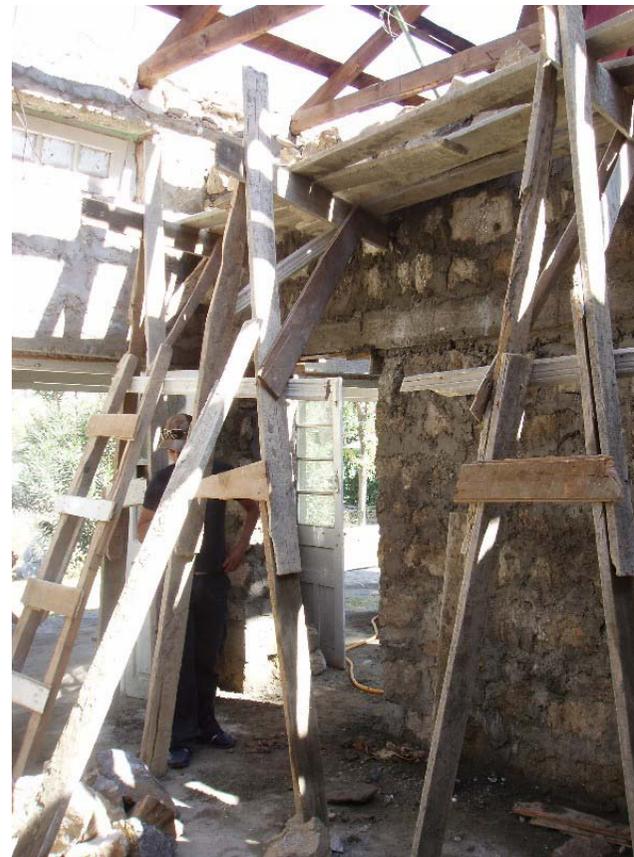
New wall with lintel

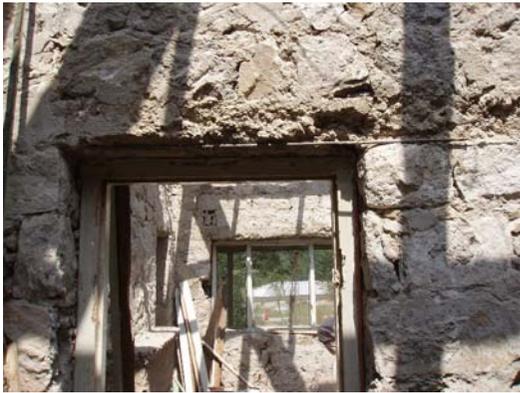
Broken lintel above the door

Most of the lintels were broken in the earthquake. The lintels have been replaced in two parts, from both side of the wall.

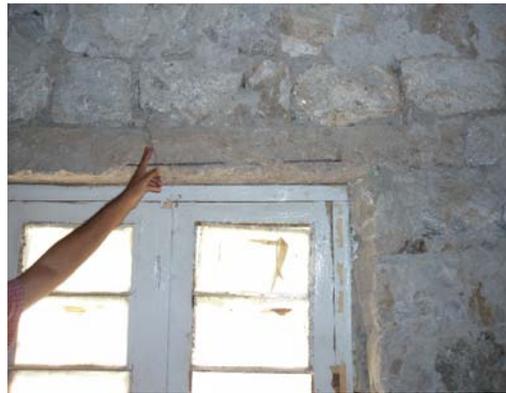
Broken lintel above the window

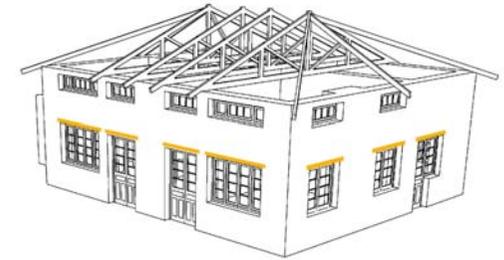
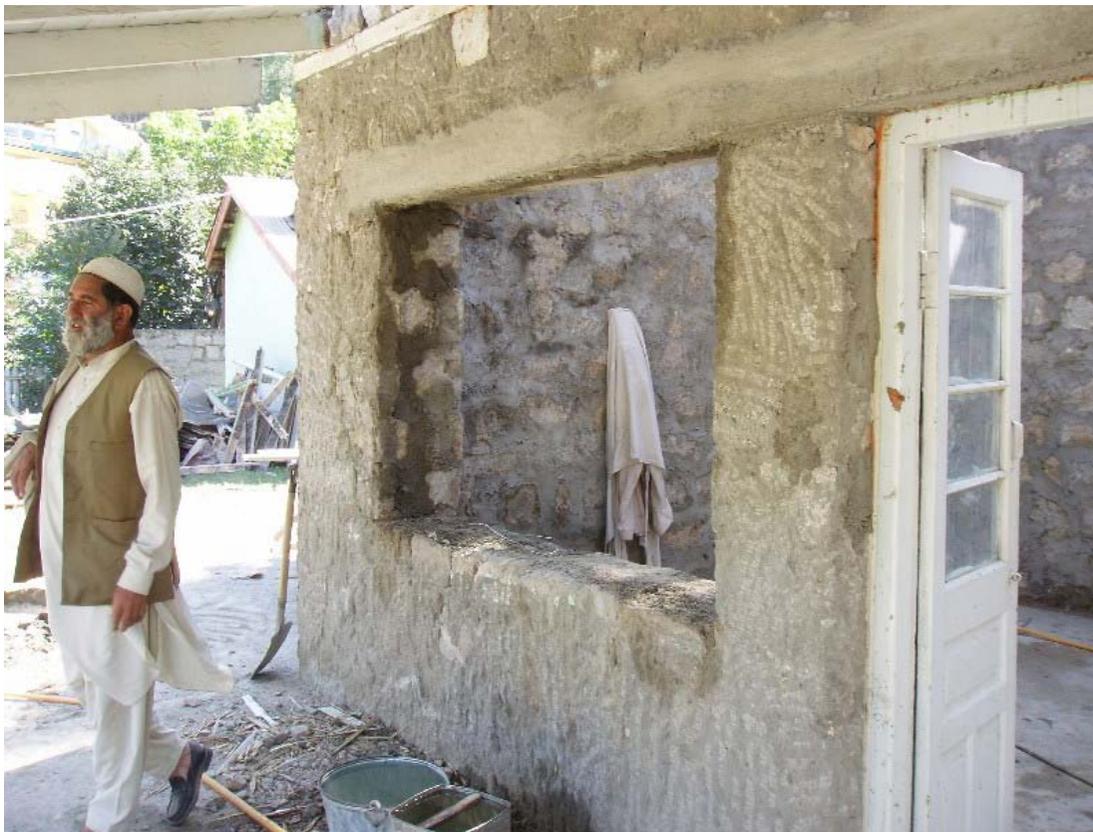
Replaced lintels above door and window

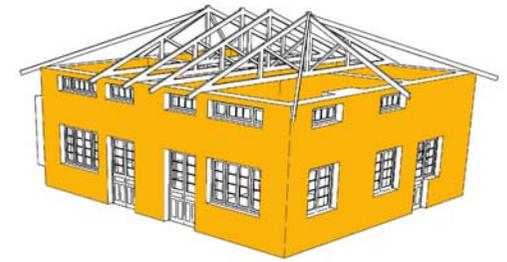
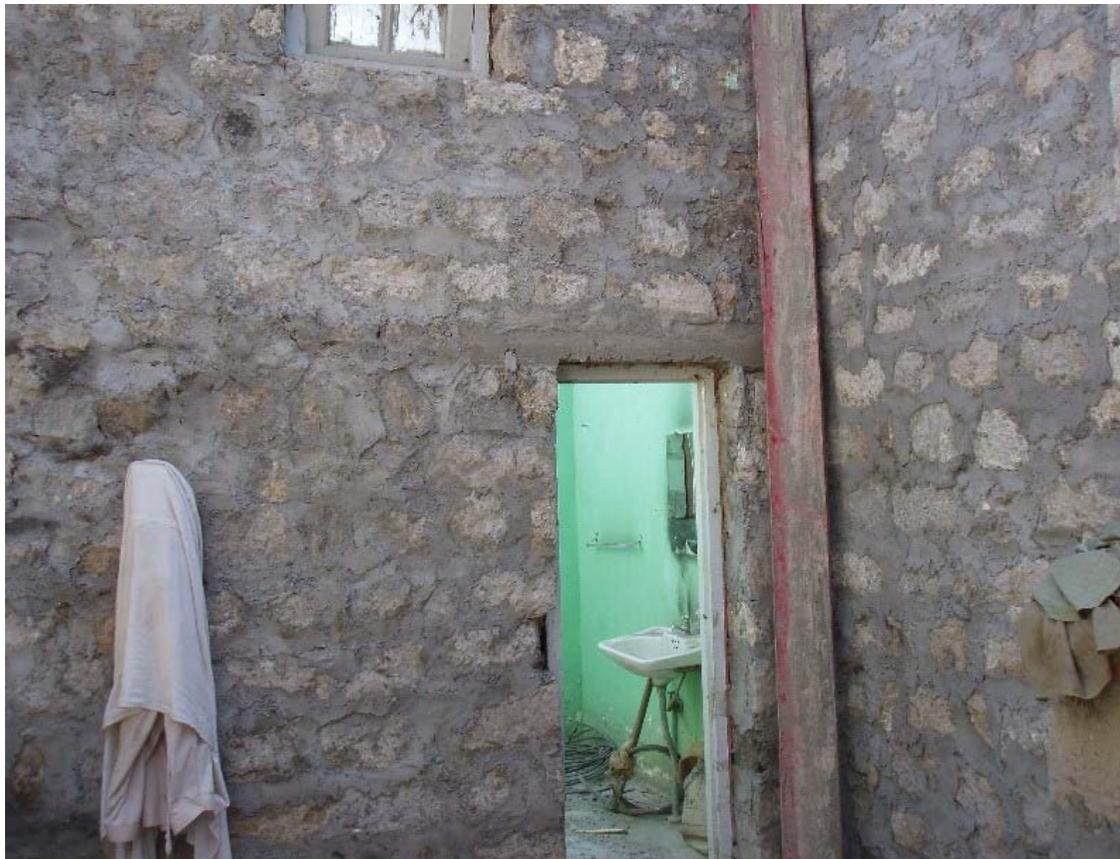
Repaired wall

All the walls have been repaired by filling cracks and bigger holes with cement mortar.

9 water : 9 cement : 1 fine sand

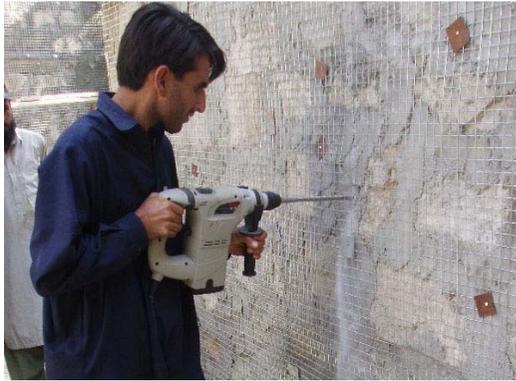
Drilling holes for the bolts

Wire mesh has been fixed on all walls with steel bolts and was covered with cement mortar in ratio 1:4

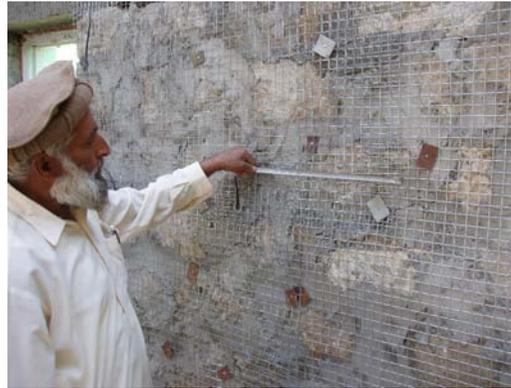
Wire meshes have to overlap 1'

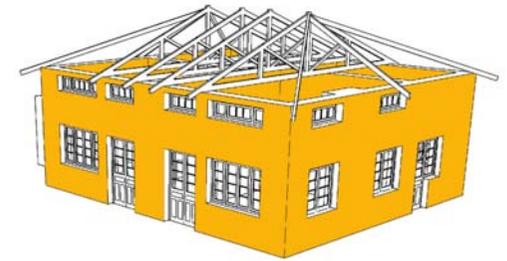
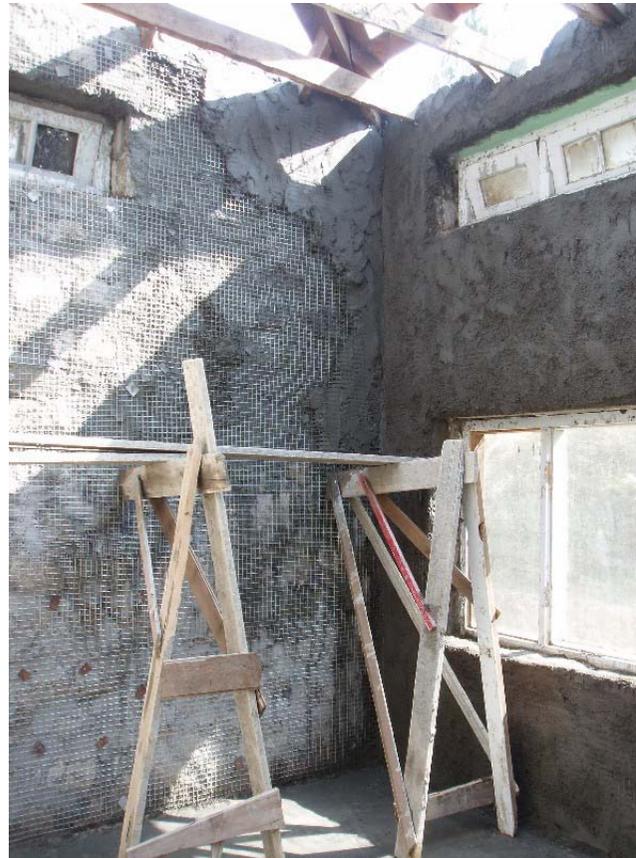
Cover of mesh with plaster

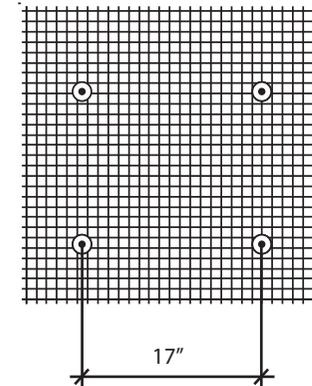
Wire mesh: MS 2mm, 1" Space

Bolt: 1/8" Diameter
