IASC Emergency Shelter Cluster

# SHELTER PROJECTS 2008

### Shelter Options 2008

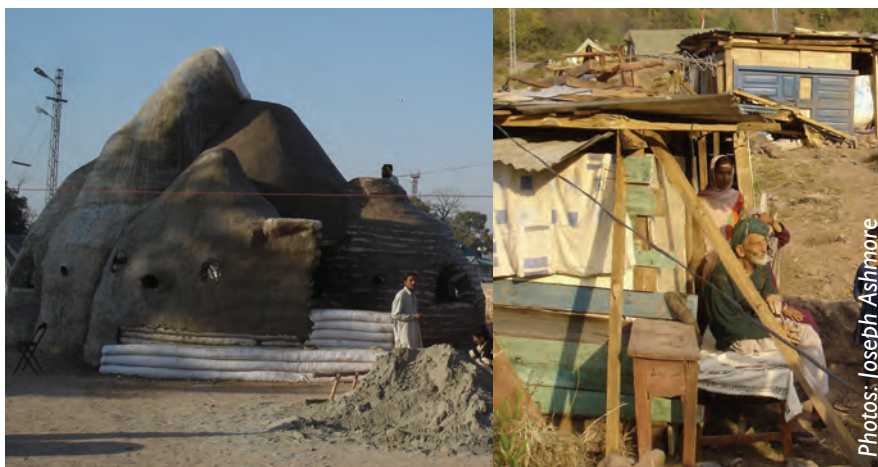
Left: Design for a timber-free domed shelter proposed as a response to an earthquake in 2005. Affectees were not involved in the design and it was not used on any scale.

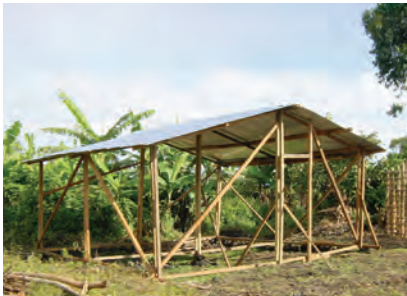
Structural skeleton of a house, showing cross-bracing

The unit was designed for robustness, without the need for cast foundations, so it could be dismantled and moved if necessary. Beneficiaries were instead encouraged to build up foundations with rocks and earth in order to reduce surface water inside the houses.

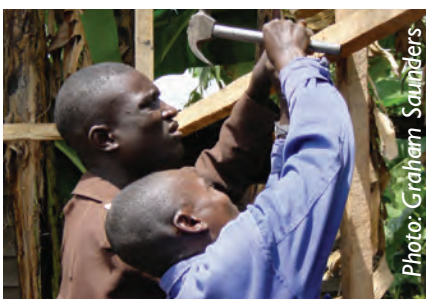
Photo: Graham Saunders

Families were trained to construct their shelters, but around 70% hired others to build.

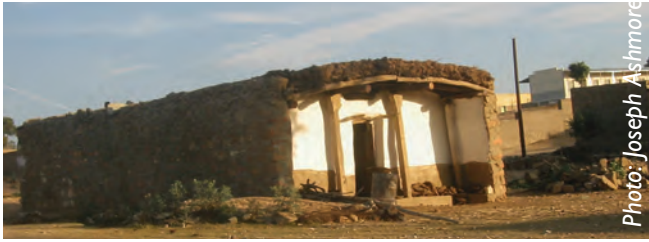
Traditional hudno house with earthen roof

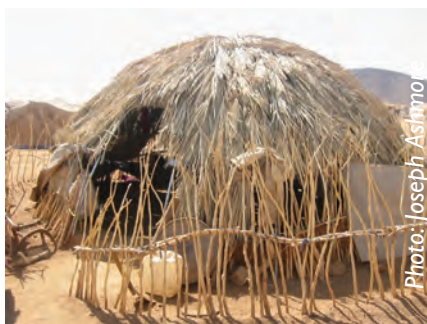
Photo: Joseph Ashmore

Palm leaves were distributed to 1,000 families.

There were trials with other materials. In 2001 the organisation distributed palm leaves for the repair of over 1,000 traditional homes in and around Barentu, in the Gash-Barka region. These were very bulky to transport. In 2004, woven mats were produced for one camp to provide a more traditional shelter material, but this was not extended to other camps.

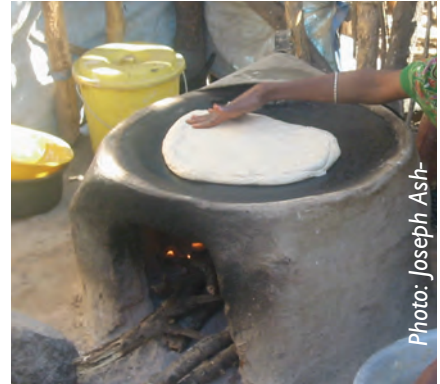
Photo: Joseph Ashmore

Firewood collection led to serious conflict with the host community. Because traditional stoves were not very efficient, an improved stoves project was set up.

In 2002, the organisation began the distribution of fuel-efficient stoves and kerosene stoves, significantly decreasing the demand for fuel wood by IDPs.

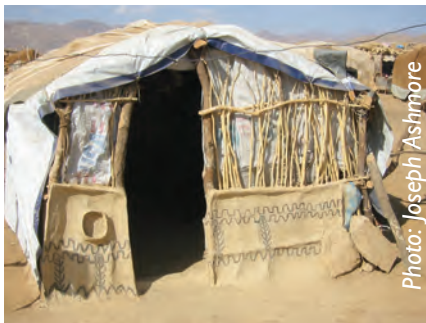
People adapted their tents in many ways.

The standard relief tent provides only 16m<sup>2</sup> of covered space (enough for a family of four people with 3.5m<sup>2</sup> per person) and many large families felt that they were living in overcrowded conditions. By modifying their shelters some IDPs managed to increase their covered floor space to around 40m<sup>2</sup> and to also ensure that they could stand up in them, something only possible in the middle of the tents.

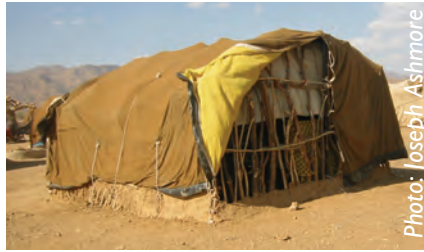
People upgraded their tents using local materials to provide more head room.

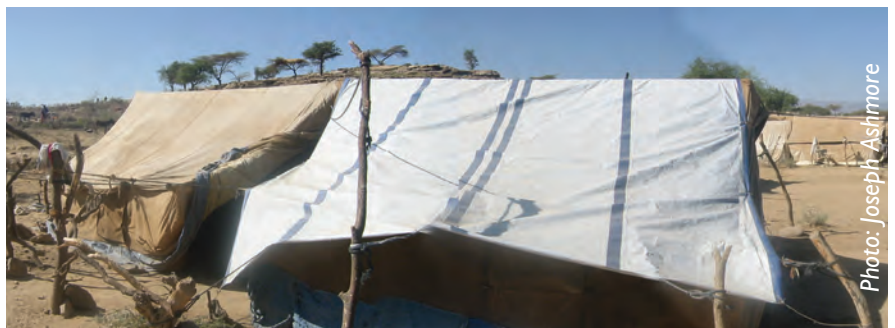
A fly sheet separated from an inner tent and covered with plastic is used to form an extension. Sticks were used to raise the sides to increase the internal volume.

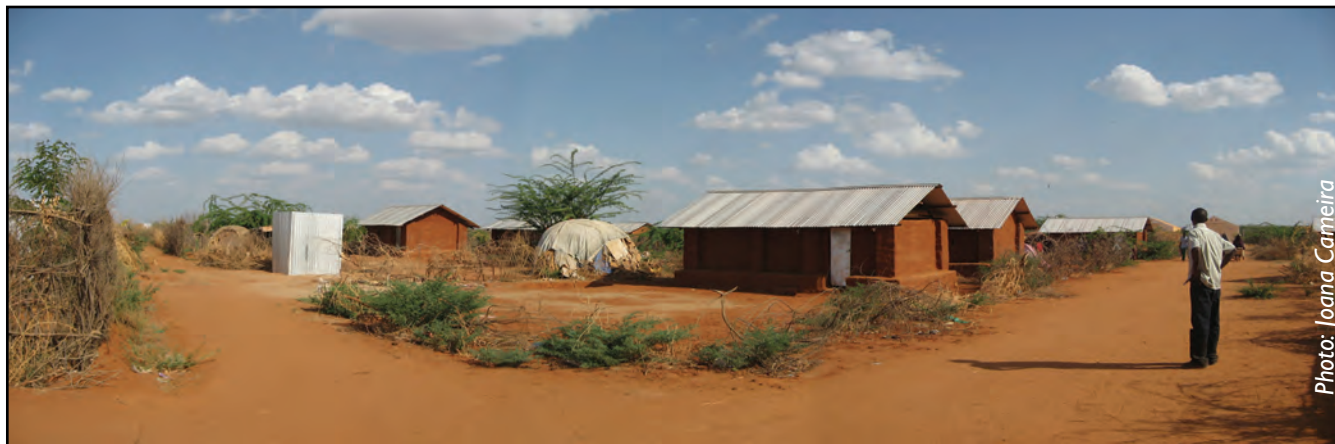
Photo: Joana Cameira

Village constructed through community-based project

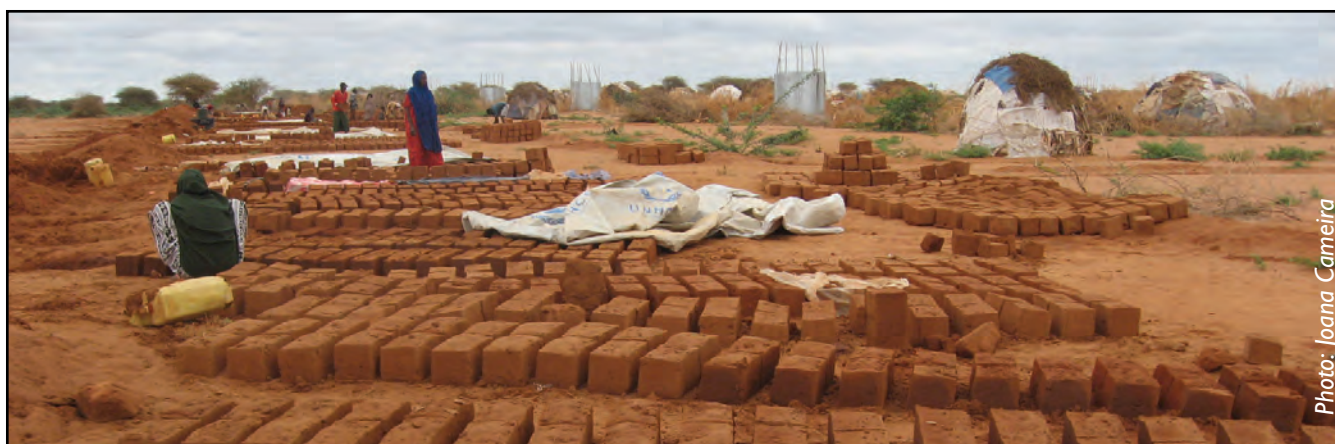
Photo: Joana Cameira

Brick production

The 6m x 3m houses required 1,700 bricks, considerably more than previous designs implemented in the camp. While disaster mitigation was primarily achieved by relocating refugees to the higher ground of Section N, extra bricks were necessary to build a thick foundation and lower wall to improve the structure's performance in heavy rains.

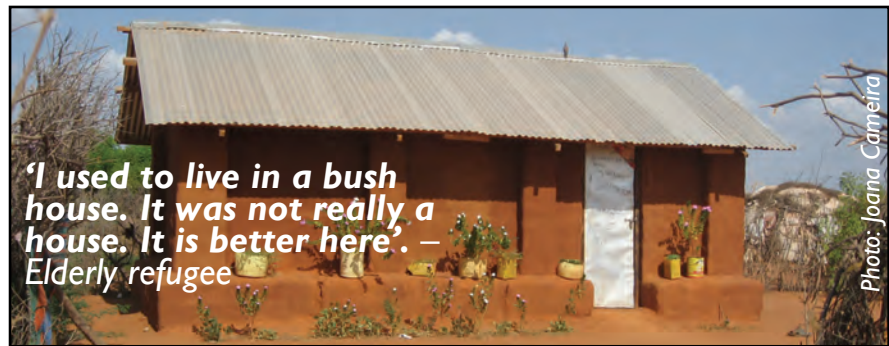
Completed house

Eight pillars provided support for the walls and roof trusses, increasing the stability of the roof itself. Mud-brick walls were plastered with

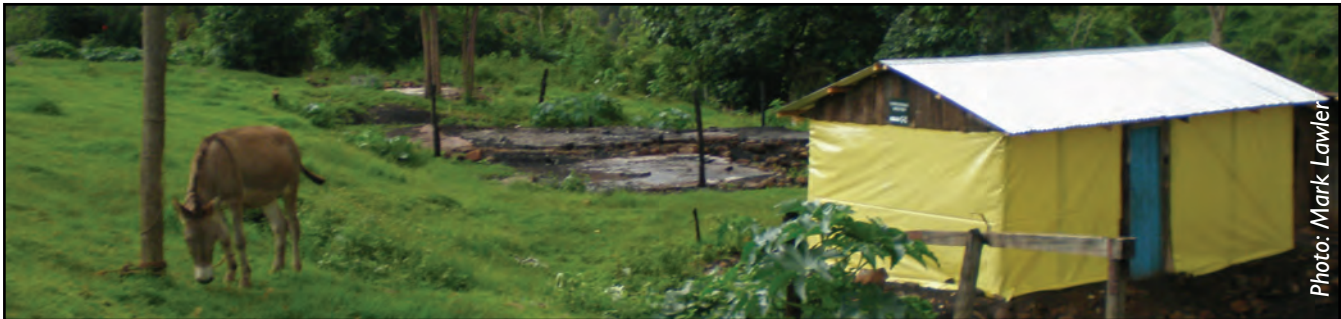
*Transitional shelter built on the family's own land*

The use of plastic sheeting allowed shelters to be built and occupied very quickly, though some beneficiaries replaced the plastic sheeting walls immediately with adobe or reclaimed building parts, such as doors or timber. The plastic sheeting could then be sold or used for temporary house extensions, and provided waterproof storage for seeds and fertilisers.

The use of regular frame and roof sections made the construction modular – it could be easily extended or adapted. The choice of materials meant that there was no part of the building that could not be fixed or replaced locally.

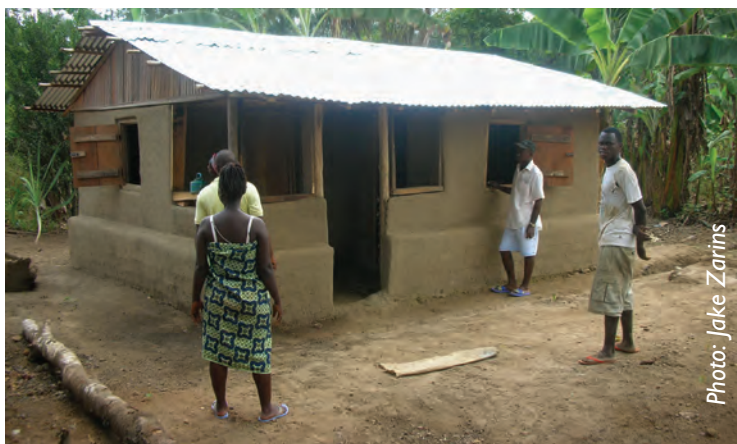
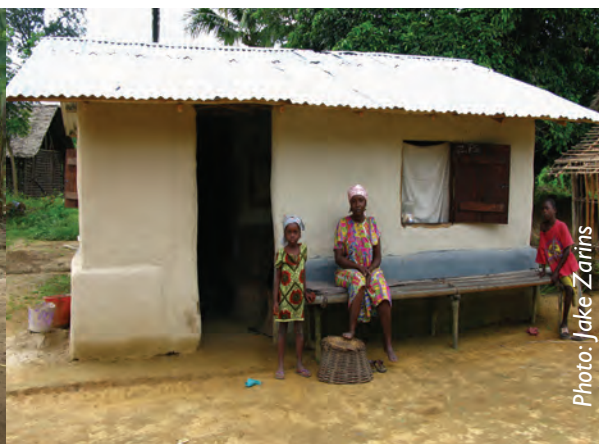
Completed houses for returnees

Many local houses do not have closable doors and windows, and walls and floors have to be frequently repaired after damage from the elements. As vulnerable beneficiaries were unlikely to be able to undertake much maintenance themselves, doors and windows were included in the build.

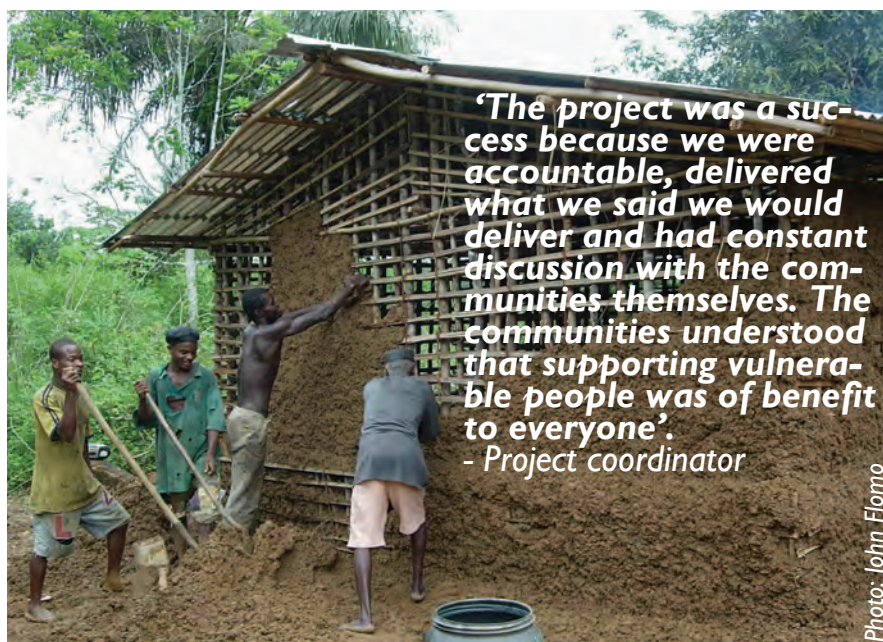
Traditional shelters under construction

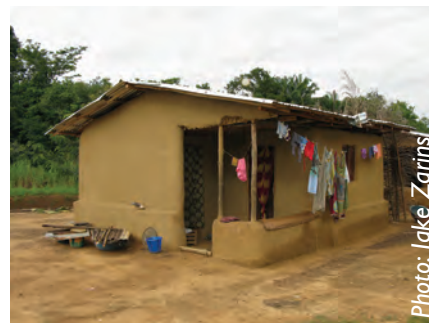
Completed house

Materials	Quantity
3" nails	65 (0.3kg)
4" nails	28 (0.3kg)
Hammer	1
Zinc roofing sheets (0.66m x 2.4m)	2 bundles
Zinc nails	1.5 packets
Door and frame	2
Window and frame	2
Hinges	4 pairs
Nails	115 (0.3kg)
Hasp/staples	4 pairs
Window and door bolts	4 pieces
Roofing felt	1 piece
<b>Materials collected locally:</b>	
Central pole	1
Poles for frame	Around 160
Rafters (poles)	50
Bamboo/rope for ceiling mats	As required

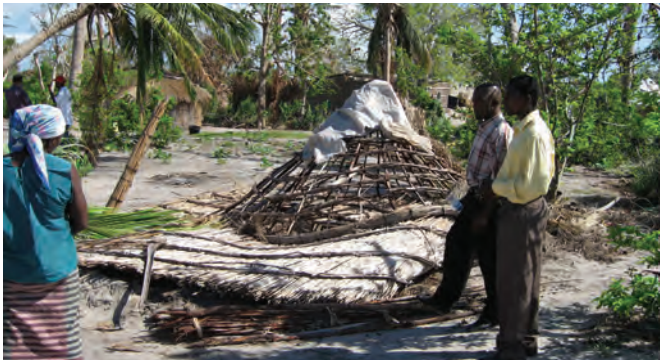
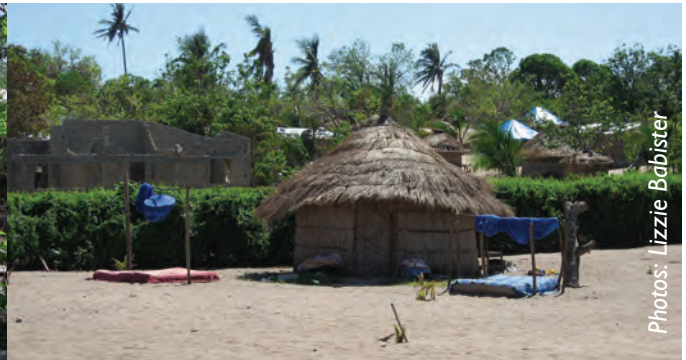
*A damaged house and self-built reconstructed house using distributed items*

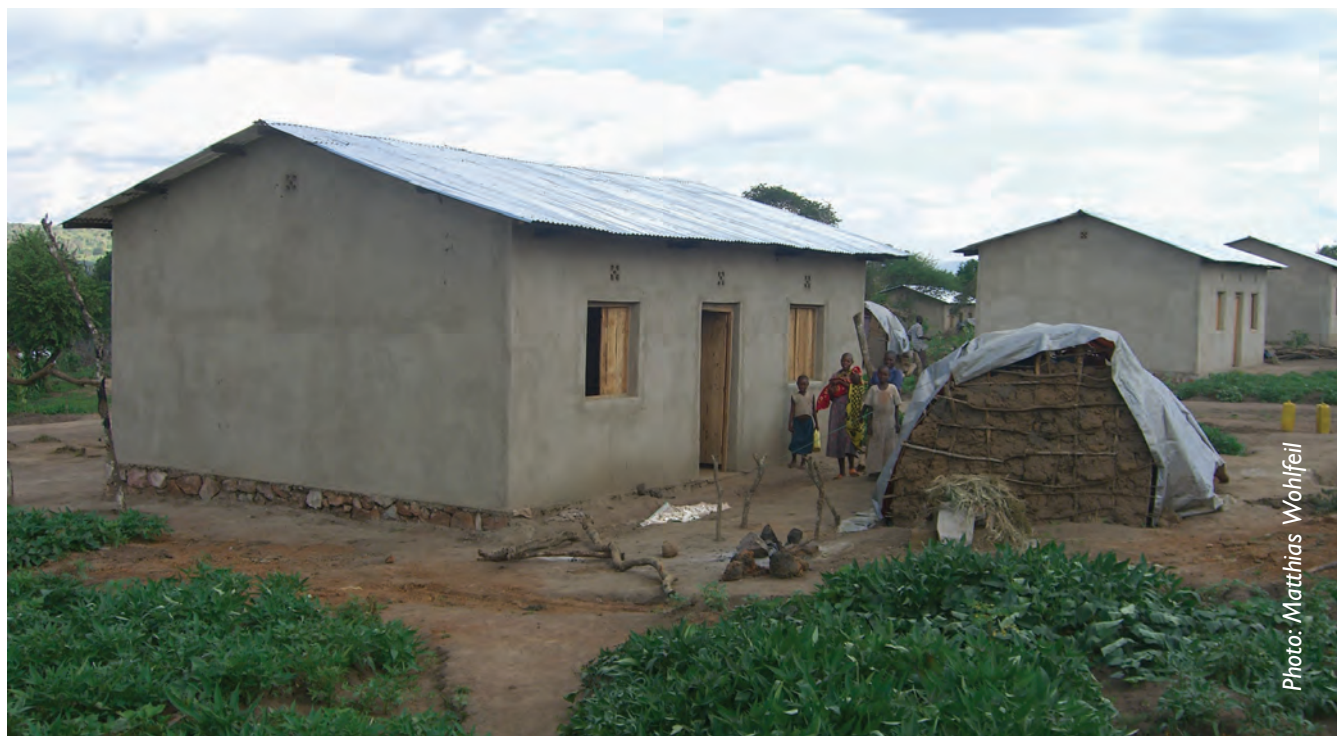
Photo: Matthias Wohlfel

Completed shelters

✗ Some houses were quickly attacked by termites as timbers had not been treated or protected.
