A.8 Somalia - 2007 - Civil conflict

Resettlement

B.I Afghanistan - 2002 - Returns

Case study: Shelter construction

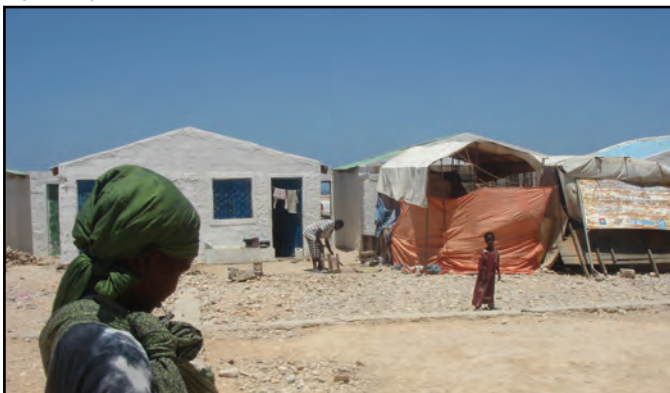
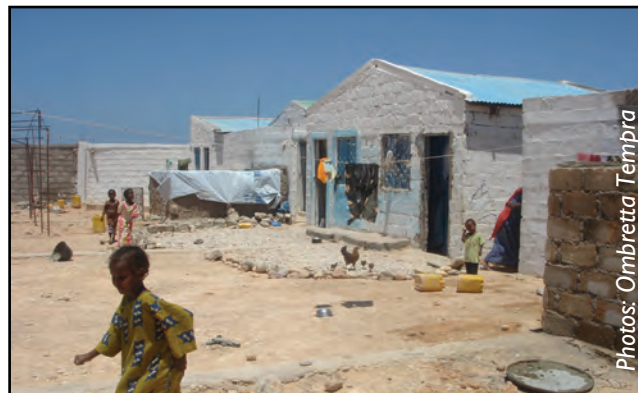
Sites and services: the project focused on negotiating land and providing access, secure compound walls, water and sanitation.

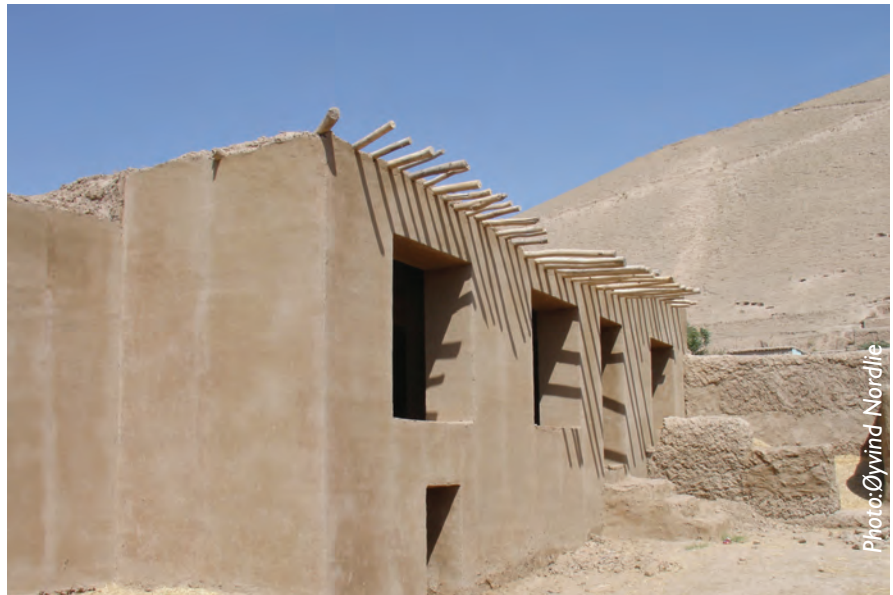
Completed shelters

This programme began building mud-block shelters with wooden roofs, windows and doors. Due to supply and sustainability issues, steel was used to replace the timber.

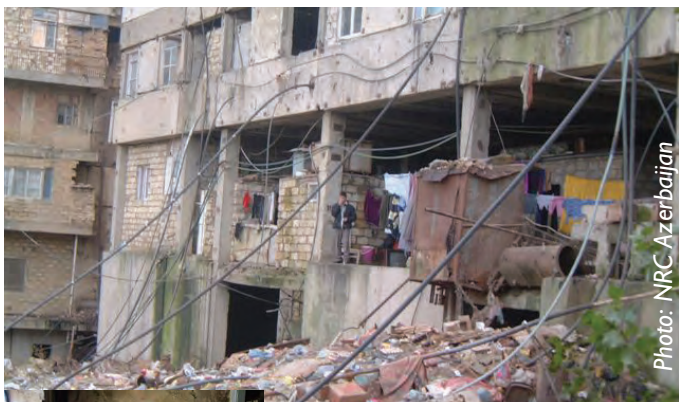
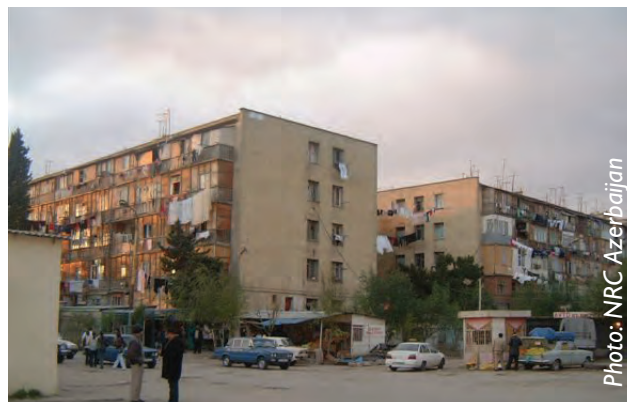
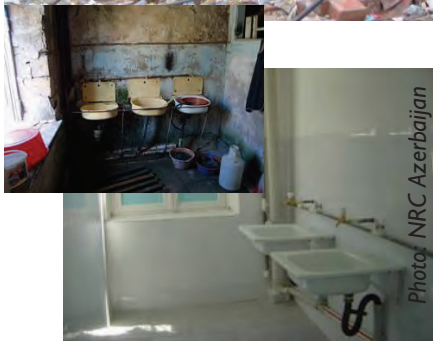
Bathrooms before and after upgrade

Inhabitants saw broken sewerage as the greatest problem in the buildings. Other common problems included shortage of water, leaking roofs and dampness. As a result, plastering, floors and ceilings in toilets and bathrooms were damaged in most buildings.

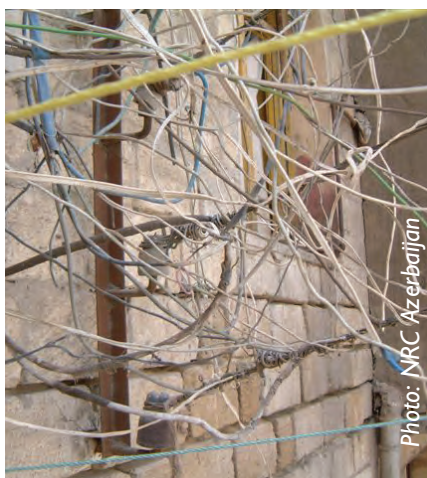
Wiring before upgrade

- rehabilitation of the shared areas - toilets, bathrooms, washing rooms, kitchens and corridors;
- infrastructure repairs - electricity, sewerage, water and sewerage pipes;
- repair of roofs;
- installation of new water heaters, sinks, stoves, faucets, showers, light bulbs, circuit breakers, switchboards, windows and doors;
- installation of electricity transformers (this was not costly but served a large number of IDPs).

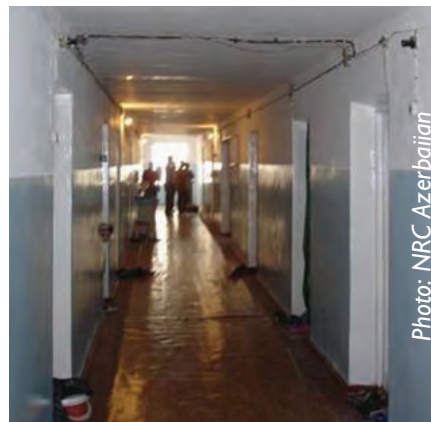
Corridors before and after upgrade

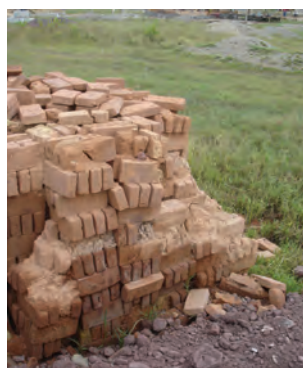
Obtaining good quality building materials remained problematic. These bricks decayed rapidly in the rain.

The availability of materials strongly impacted the shelter designs used. There were significant challenges in obtaining legal timber locally, while importing timber was slow and problematic. Strangely, the amount of wood burned to make bricks may have had a larger environmental impact on the local forest resources than using timber would have done.

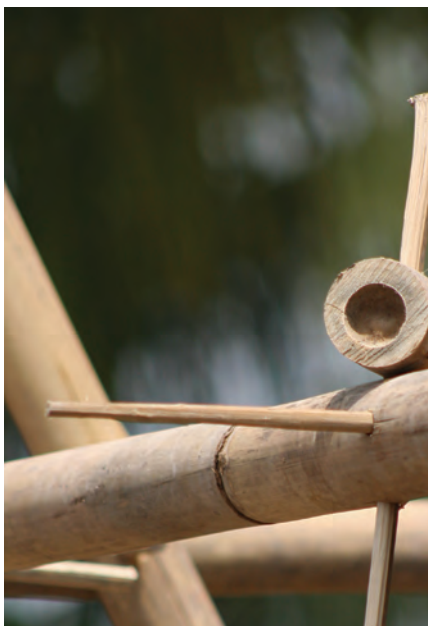
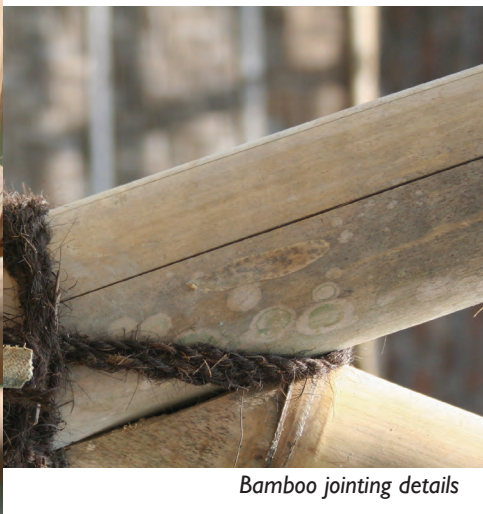
Bamboo jointing details

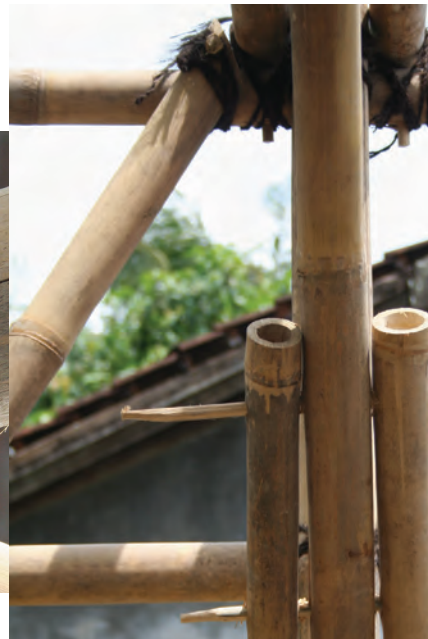
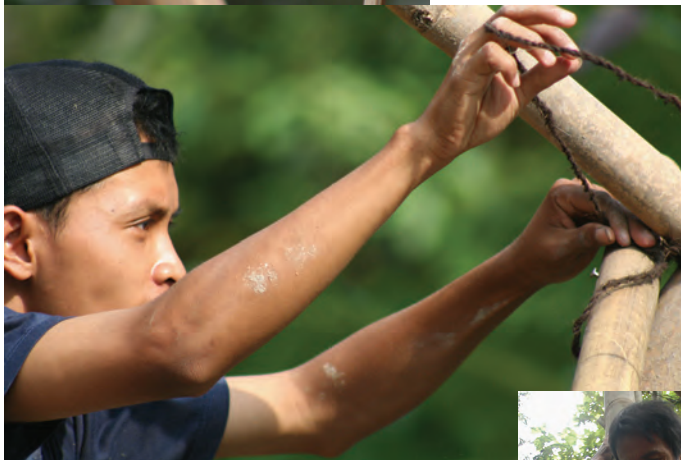
Bamboo being bound with string

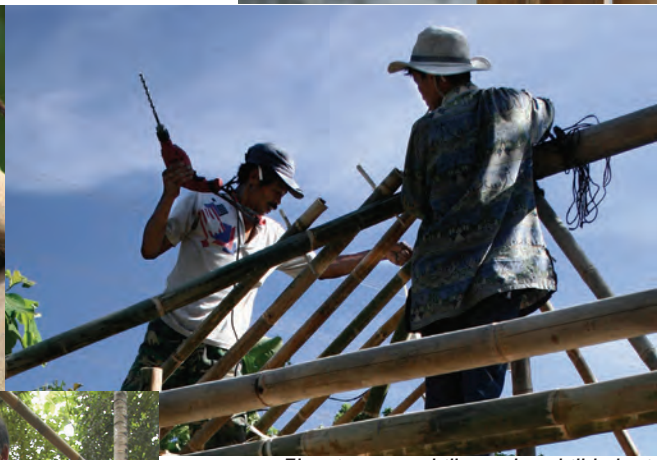
Electric power drills used to drill holes in the bamboo so that it can be pegged

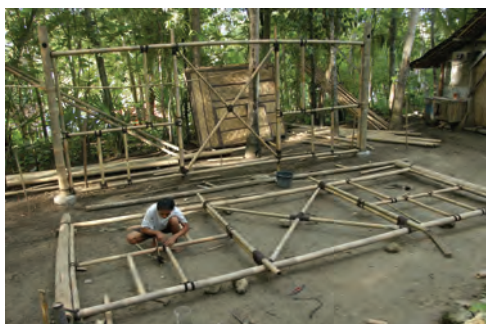
Prefabrication of a wall panel

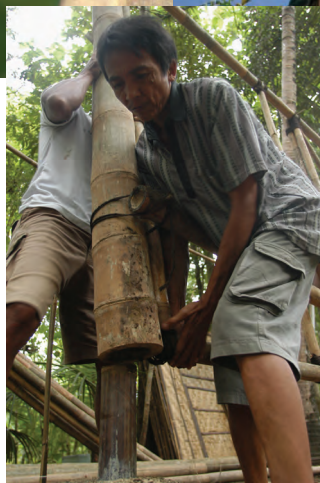
Connecting a vertical post to the foundation

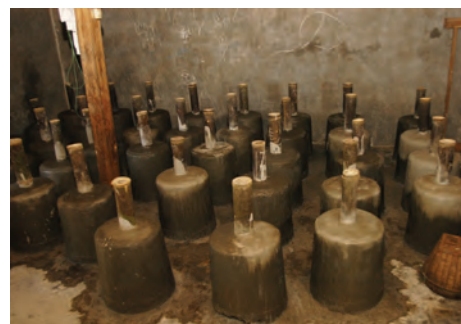
Foundation pads cast with bamboo to connect them to the frame

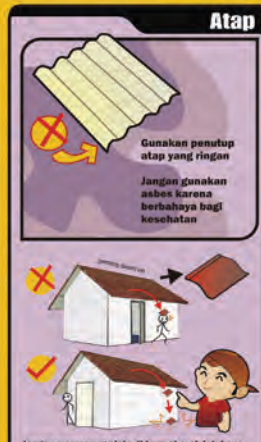
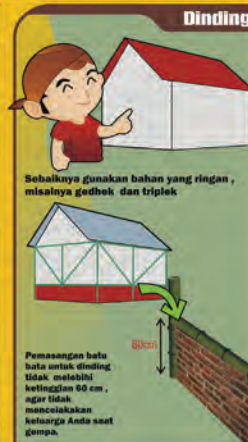
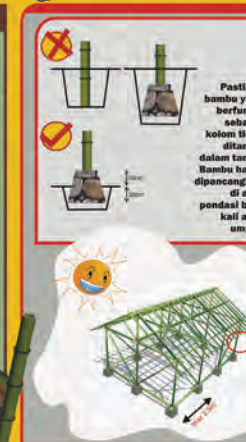
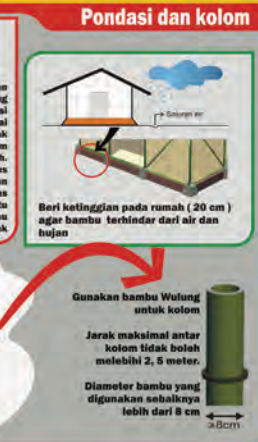
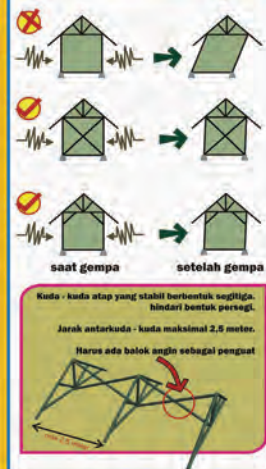
MARI MEMBANGUN RUMAH CIKAL DARI BAMBU

01. Pondasi

04. Dinding dan Penutup atap
