## B.10 Pakistan - 2005 - Earthquake

### Case Study: Transitional shelter construction

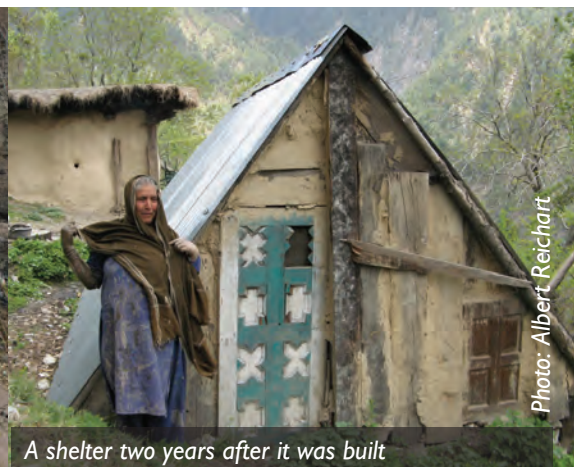
A shelter two years after it was built

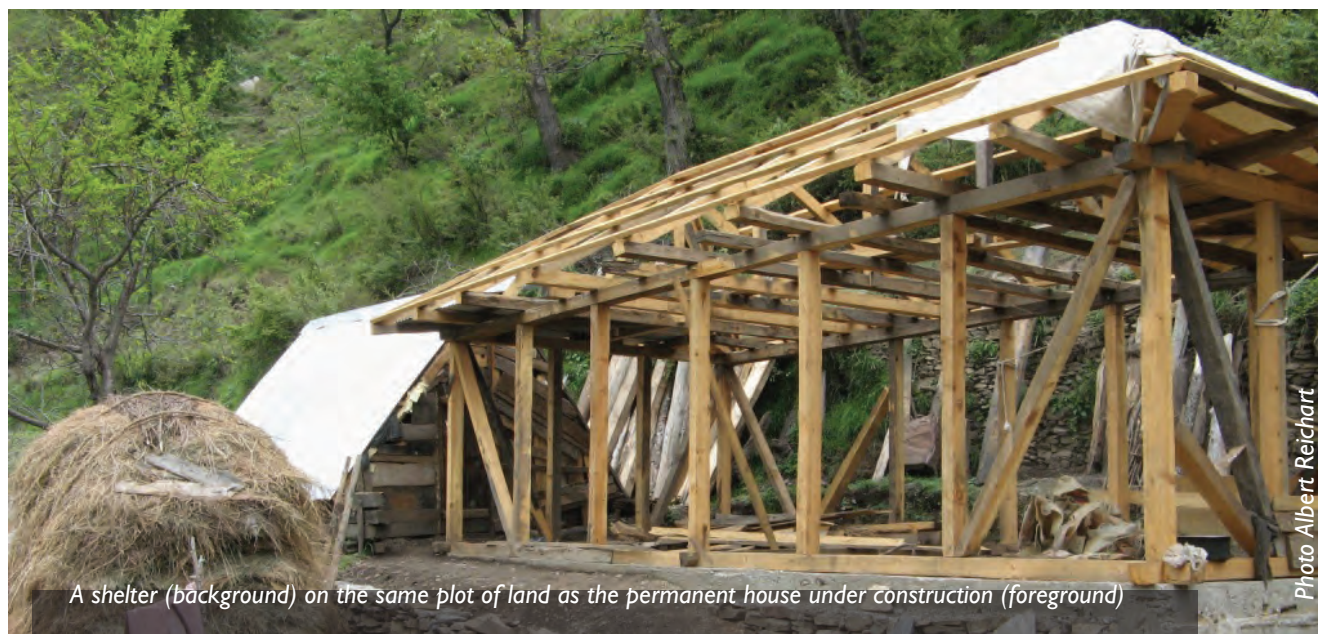
A shelter (background) on the same plot of land as the permanent house under construction (foreground)

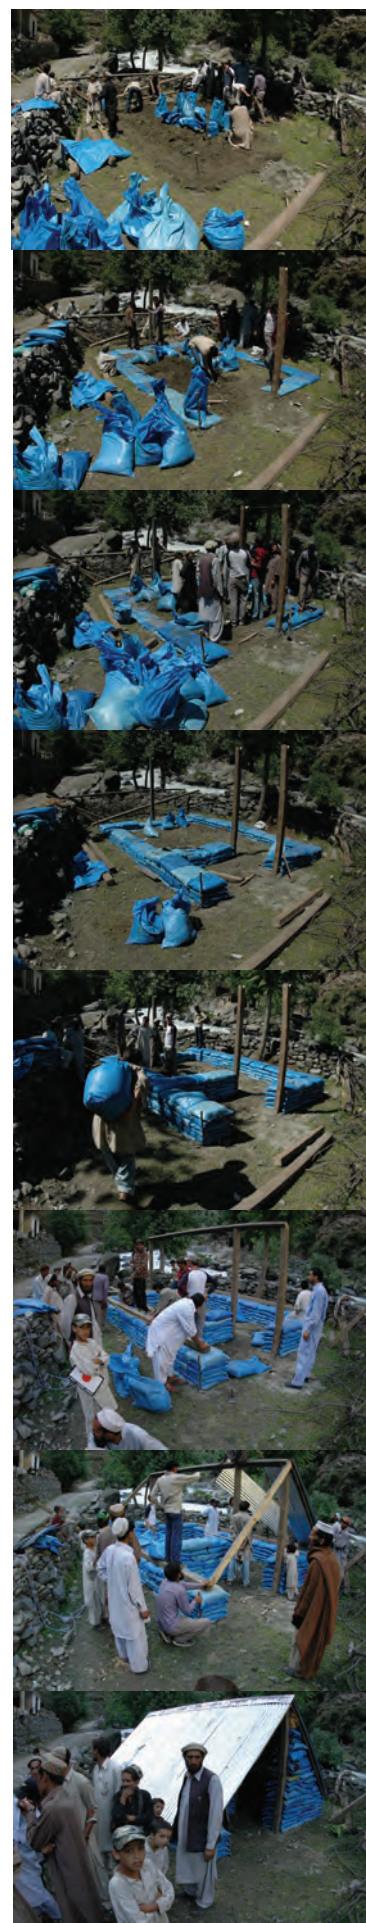
Building one of the transitional shelters

The shelter design had low walls and a sloping corrugated iron roof. It provided covered space for people and for their livestock (at one end). Its base was made of soil. On this base, walls were built out of polypropylene sacks filled with soil. The higher parts of the wall were made from sacks filled with lighter materials, such as crop wastes, straw or pine needles. The roof was made from corrugated iron fixed to a reclaimed timber frame. Additional sandbags were provided with the intention that they would be filled with lightweight material and placed against the corrugated iron as insulation.

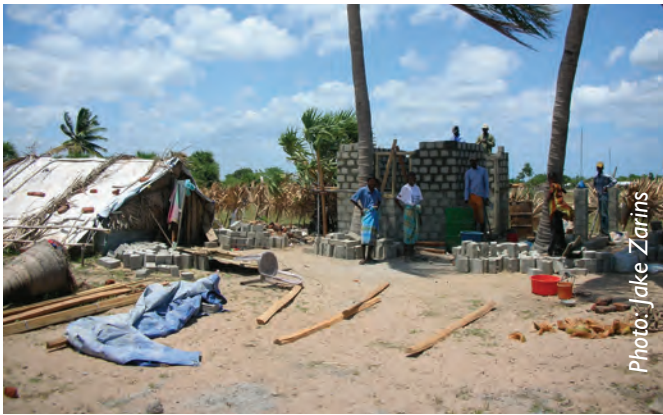
Core shelter under construction

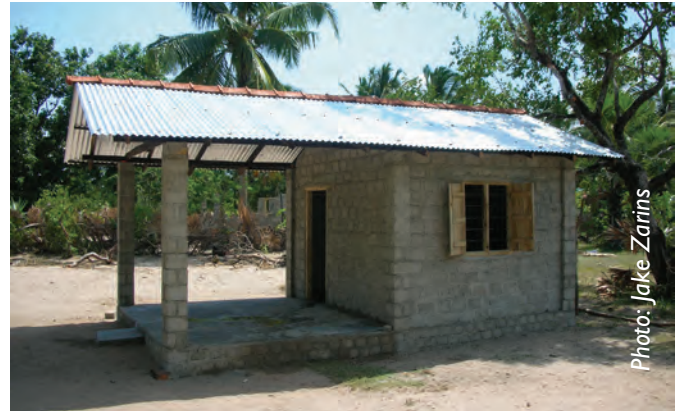
Completed core shelter

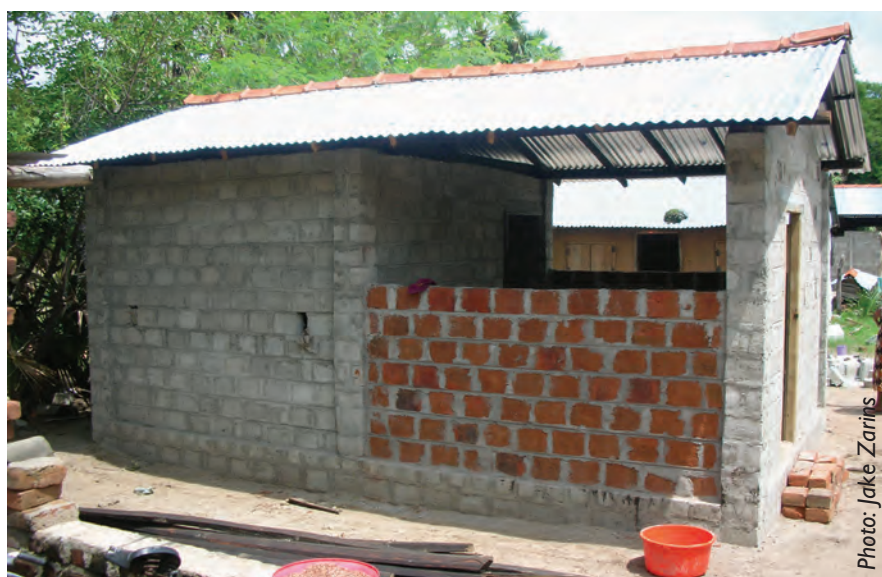
*A durable upgrade of a core shelter*

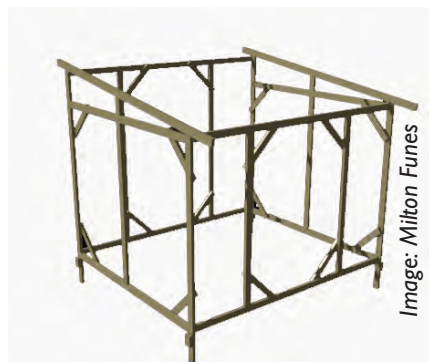
Computer model of the timber frame of the shelter

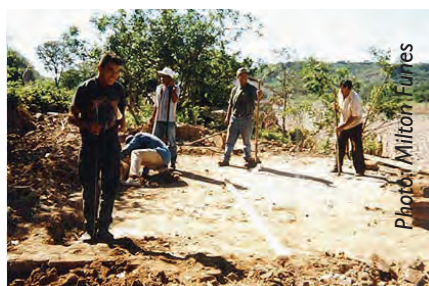
Marking out the site for a shelter

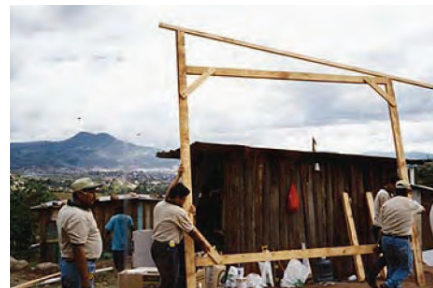
Shelter assembly using prefabricated walls

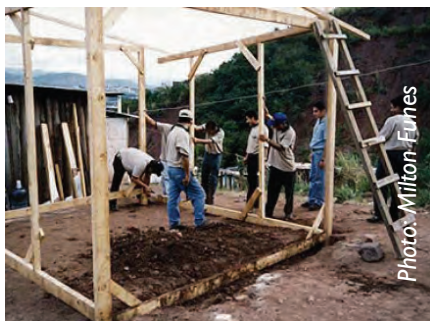
Completing the frame

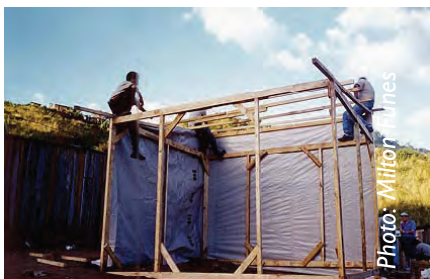
Covering the frame

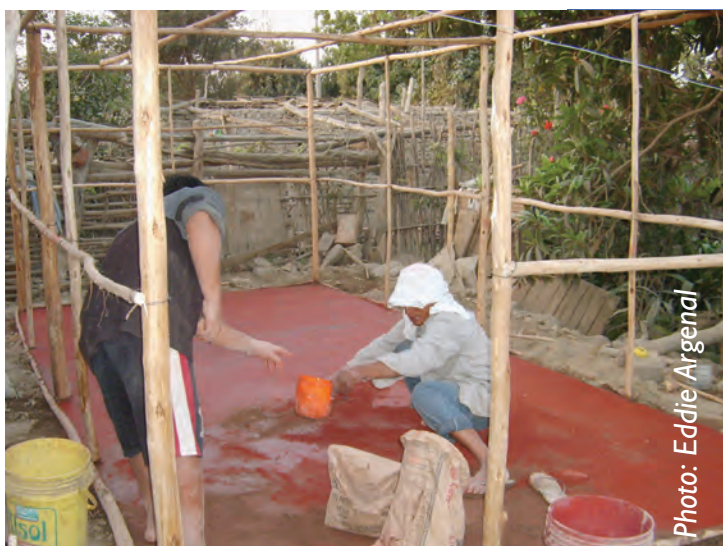
Making the concrete floor slab

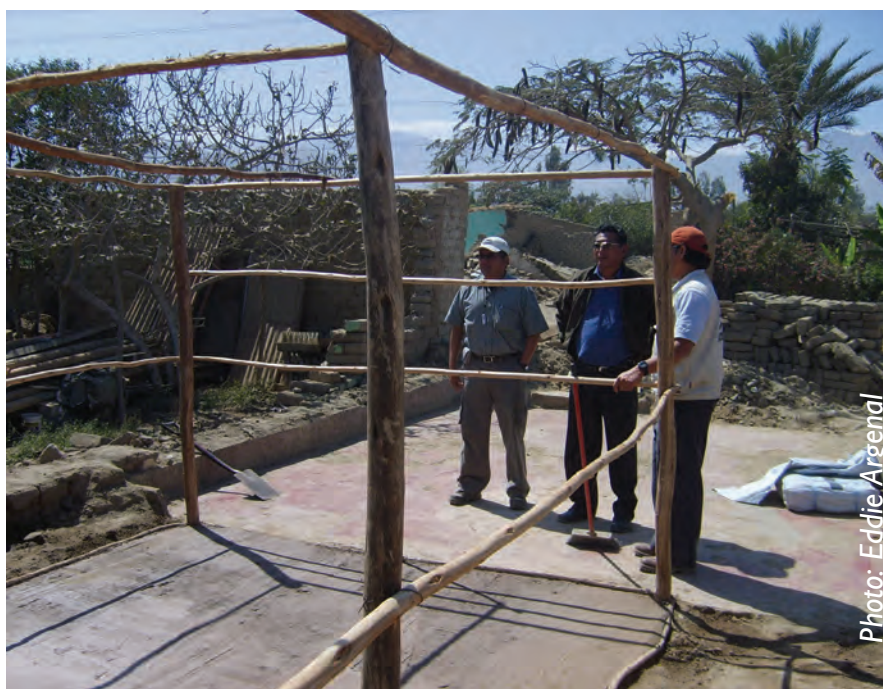
*Round poles, not sawn timber, were used*

Timber poles proved easier to procure than sawn timber and the local population was accustomed to building with them.

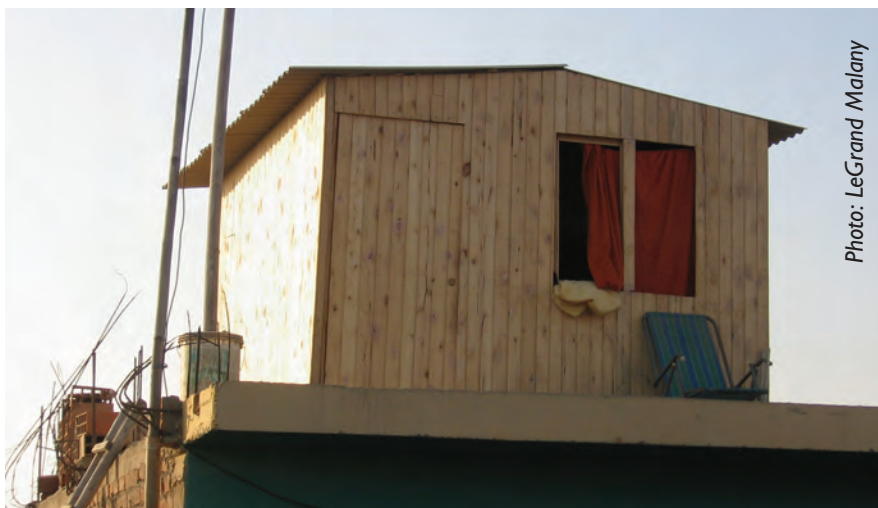
*Completed shelter built on the roof of a damaged house*

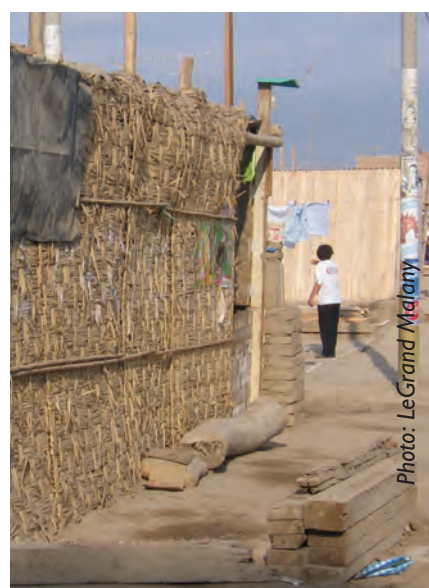
*One of the project's shelters (background) and a shelter walled with reed mats (foreground)*
