Section D

Historical Case Studies

D.I Historical case studies - overview

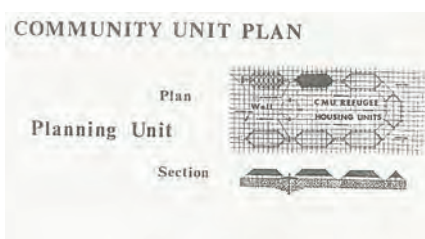
U-shaped community block plans

The layout of the camps was based upon small U-shaped clusters of shelters. These were later simplified to square clusters in some camps. Space within the U was intended for the use of women, particularly those observing purdah. The areas outside the U shape, along the access routes through the camp, were intended for use by the men. In this way, the public men's area was also intended to be made available for workshops or other livelihoods activities, and also gave each community more control over the public space nearest their shelter cluster. Washing and cooking areas were contained within each cluster.

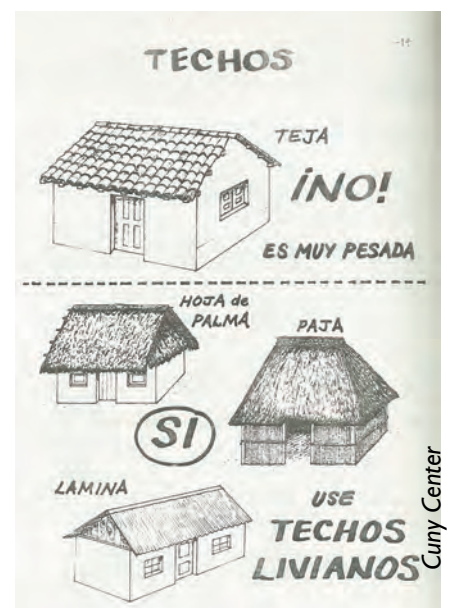
Options for roofing materials - tiles, palm leaves, thatch, corrugated iron

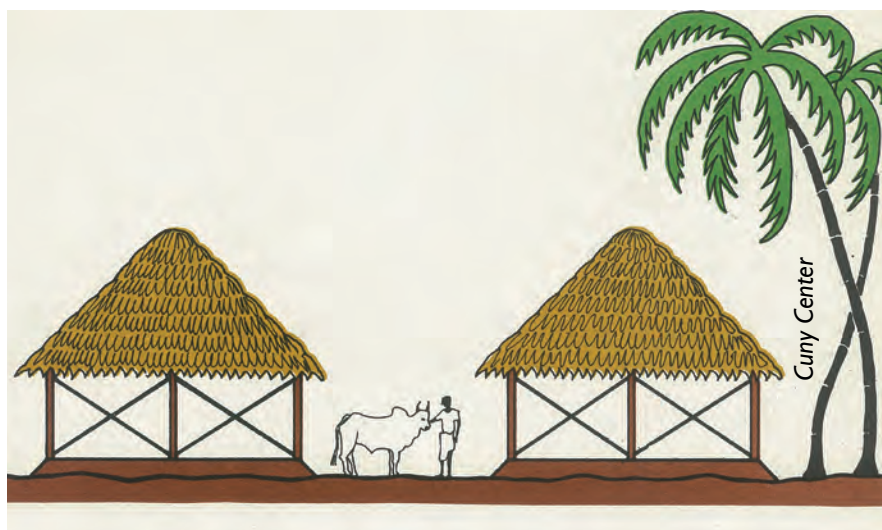
Shelter design elevation showing cross-bracing

The initial construction efforts were evaluated three weeks into the programme. Based on the evaluations, improvements and additions were made (cross-bracing and the protection of the housing posts below ground level) in the guidelines and prototypes.

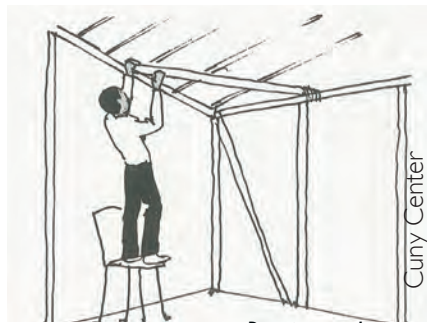
Bracing techniques

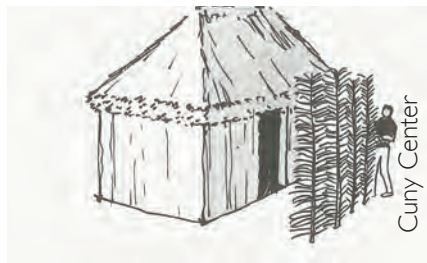
Wind resistance techniques

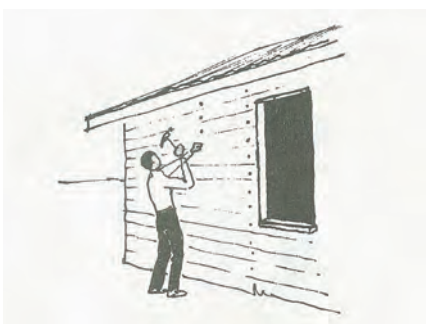
Safe wall cladding fixture
