Reconstruction of Schools/Storm Shelters in the Cyclone Nargis affected Delta of Myanmar

Compilation of “Lessons learnt” of Phase 1

December 2010

Daniel Schwitter Architect Skat, Switzerland

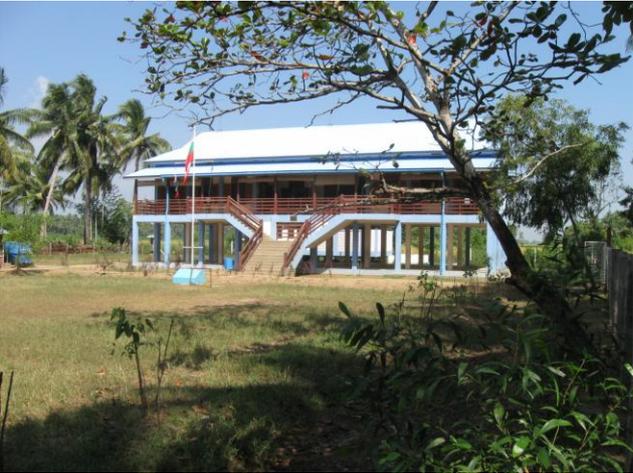
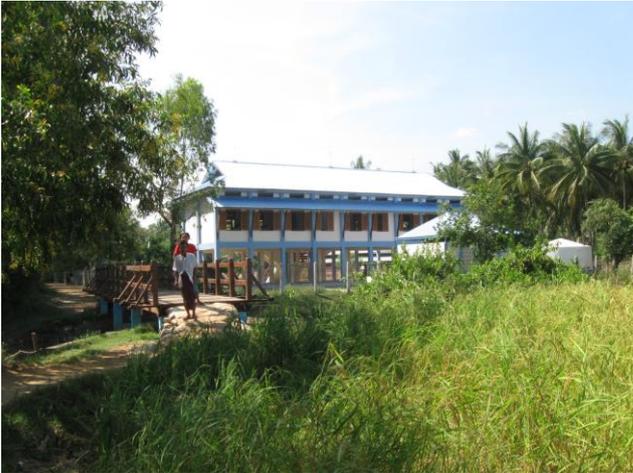
Structure: The building is structurally stable, weatherproof, covered with high quality roofing sheets according to local environmental conditions, climatically comfortable, easily exited in case of emergency and well integrated in the environmental and cultural context.

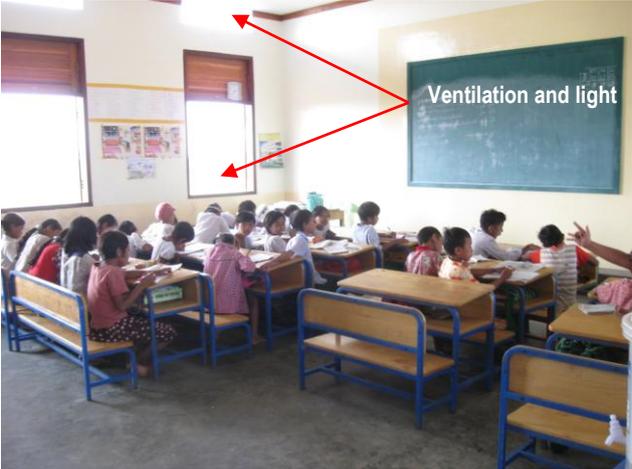
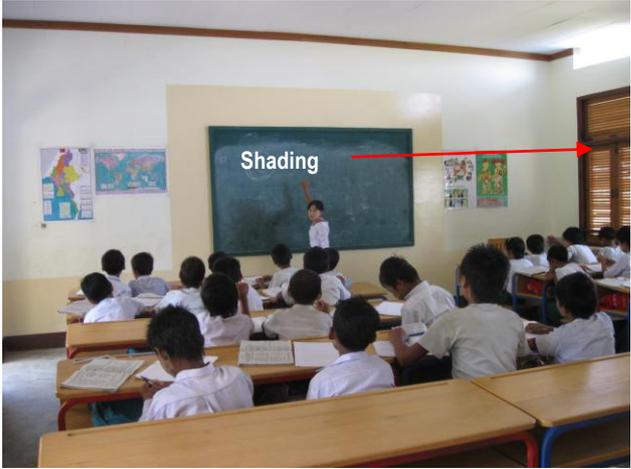
Light, air, sun, dust, glare, reflection, humidity: Classrooms have good fresh air circulation to avoid heat and excessive humidity. To ensure adequate daylight, more than 20% of the classroom floor area is window area. Classrooms are sufficiently shaded from direct sunlight, glare (direct light) and reflection (indirect light).

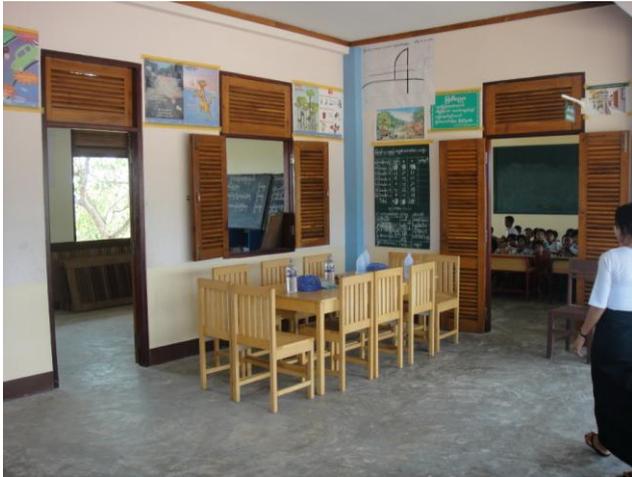
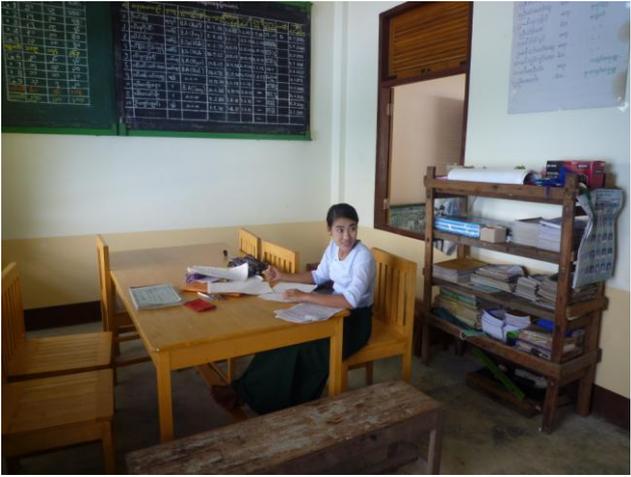
Administrative offices / Teacher's room: Separate space for teachers/administrative personnel gives privacy to teachers and maximizes the use of classroom space, enabling staff to work separately from students. Proximity between classrooms and administrative offices is given to monitor students' activities and create 'safety through transparency'.

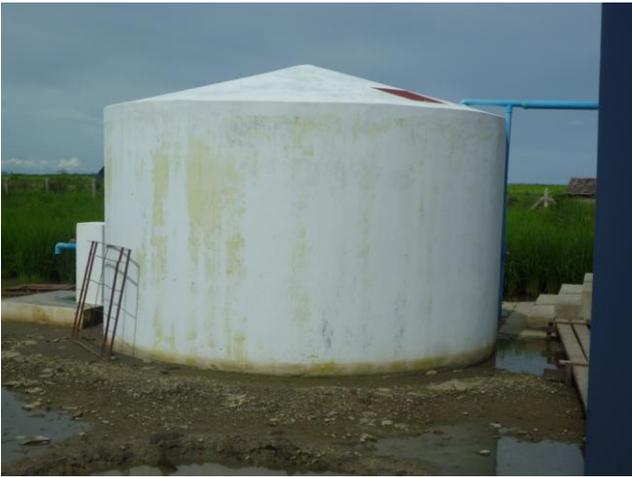
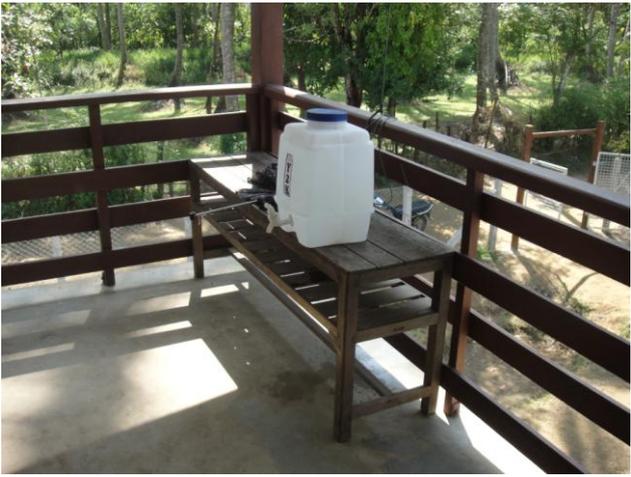
Safe water: Potable water is available to students within the school fed by a rainwater catchment system in the roof and purified by Kathadyn filters provided by SDC-HA

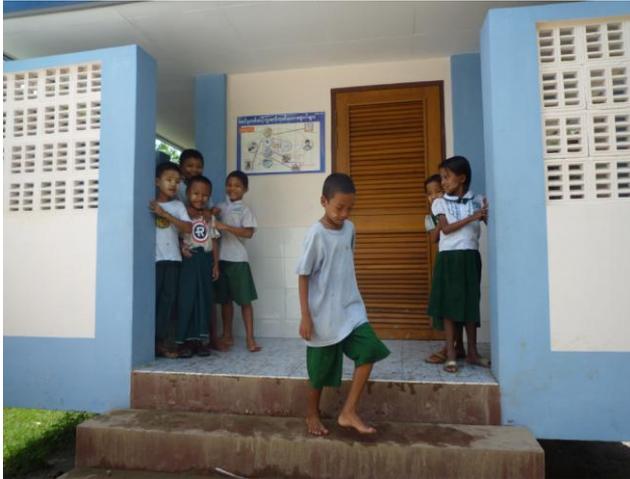
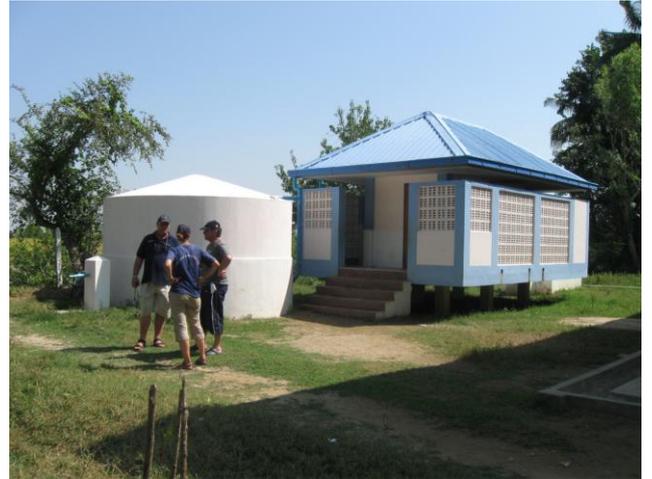
Toilets/latrines: Separate toilets are available for girls and boys (the Watsan system will be re-designed)

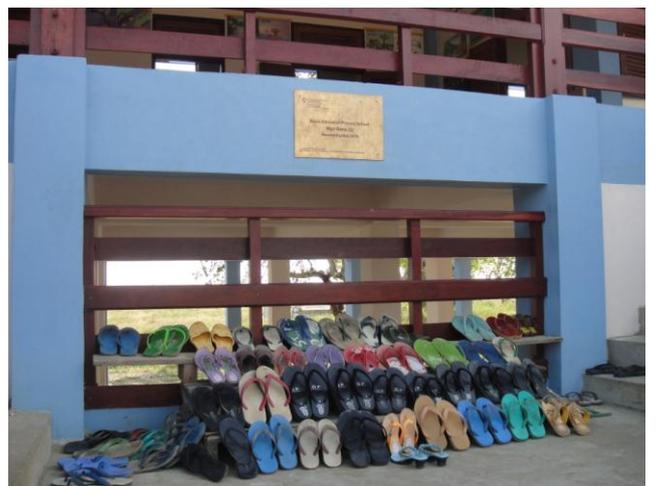
Hygiene facilities: Separate space is provided for shoe racks and basins are available with water and soap for children to wash their feet/hands.

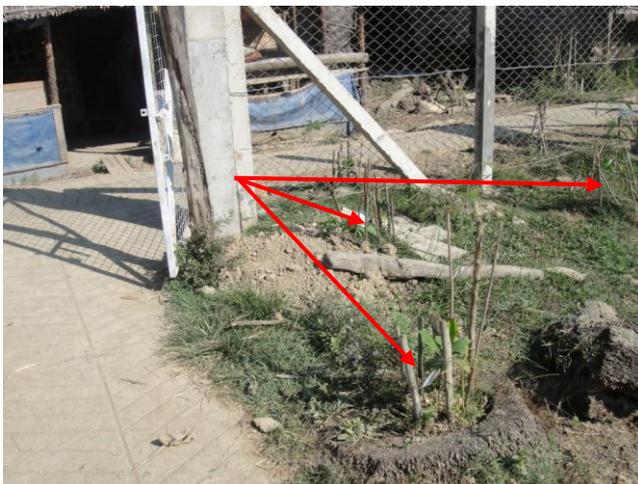
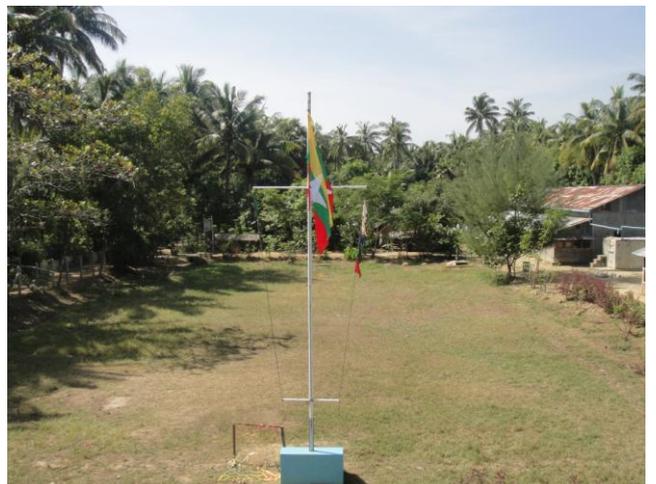
Compound: The planting of trees, shrubs and other mangrove vegetation within the school compound contributes to the ongoing process of **environmental regeneration** and protect these infrastructures. It further enhances ownership and pride in maintaining the assets.

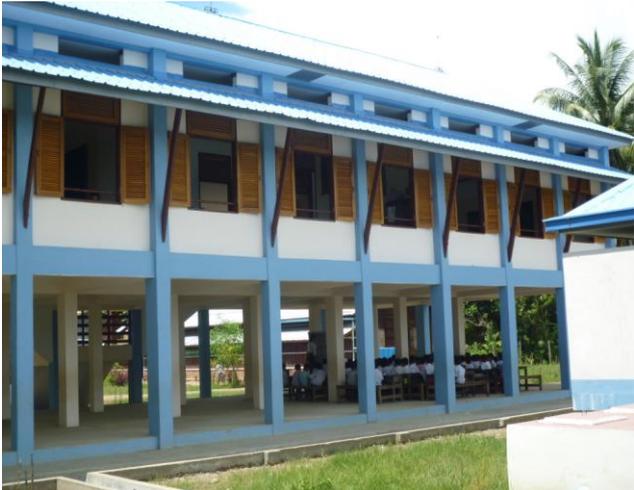
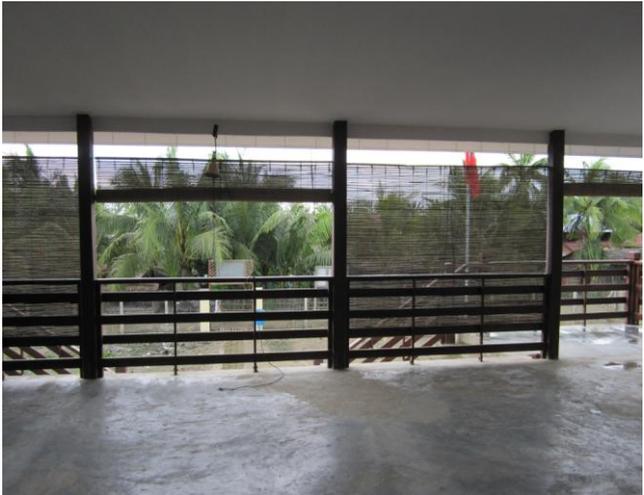
Colors and finishes: Materials and finishes are in light, natural colors with materials selected in harmony by local, cultural preferences. For example, timber is finished using clear varnish to preserve the natural beauty and warmth of the material.

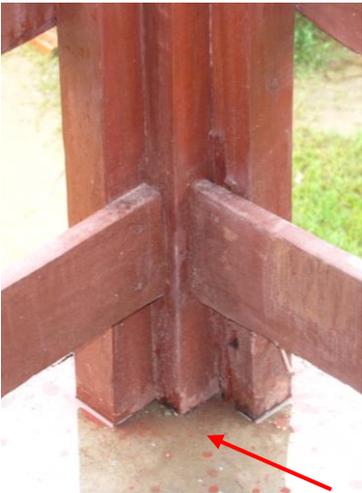
Finding 1: Wooden columns of veranda roof and handrails

Shortcoming: the wooden columns are exposed to stagnating water at the base

Implication if not rectified: risk that the wooden columns will be rotten and reduce the stability of the veranda railing and roof.

Stagnating water at veranda columns

Required improvement: the columns have to be out of stagnating water and placed on a steel plate or a concrete base.

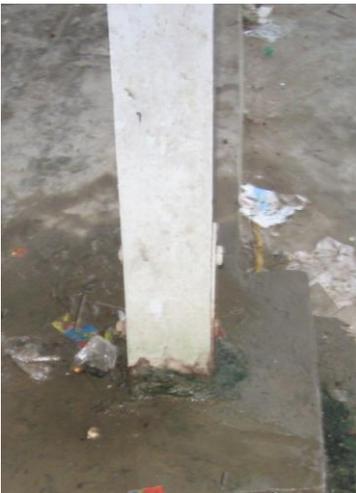
Damage due to stagnating water at veranda column of a 2 years old government school

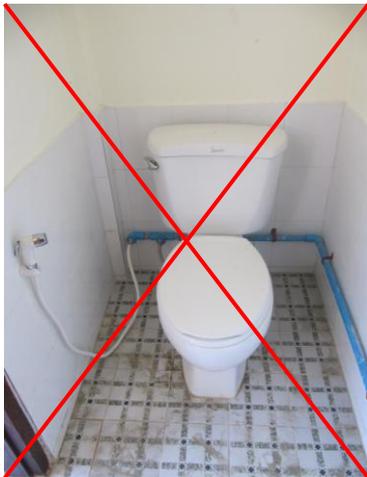
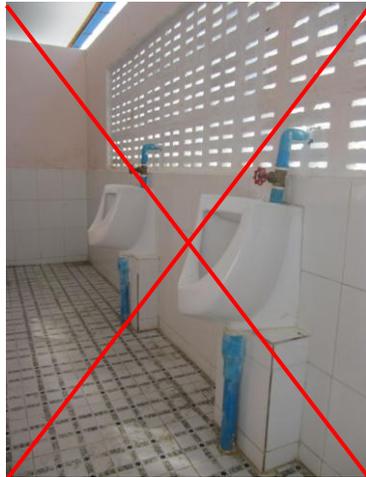
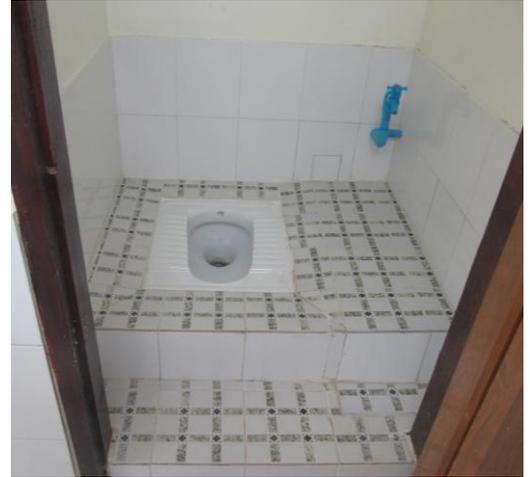
Shortcoming: The school toilets are equipped with one western WC-pan (in consideration to provide access for handicapped), ceramic sink and urinals. The availability of enough running

water to flush these sanitary apparatus is very limited. Children and villagers in rural areas are not yet familiar with such appliances. Cultural context and common practice needs to be considered.

Implication if not rectified: Due to the scarcity of running water there is a risk that these modern sanitary appliances will not function.

Appropriate floor pans flushed by bucket and fed with tap or shallow well

Required improvement: All toilets (including teacher's and handicapped toilet) should be equipped with common floor pans (Asia type) that can be flushed with a water bucket. Urinals are not appropriate and unnecessary.

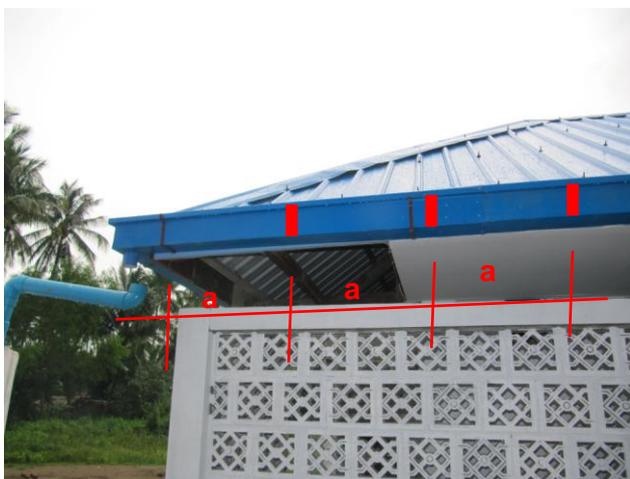
Shortcoming: The roof gutters are not sufficiently fixed in a sustainable manner. The hooks are of poor quality and the distance in between is often too big.

Implication if not rectified: strong winds, heavy rains and hot sun will cause deformation of the gutters and make the use of rainwater impossible.

a = max. 60 cm

Required improvement: roof gutters must be fixed with solid hooks placed at a distance of max. 60 cm. The veranda roof gutter does not need a downpipe. The water can be discharged by an open outlet (Ausspeier) with an adequate open drain out of the compound. The discharged water could also be caught in a simple collecting tank and used in rainy season by children to wash their hands and feet before entering the classroom.

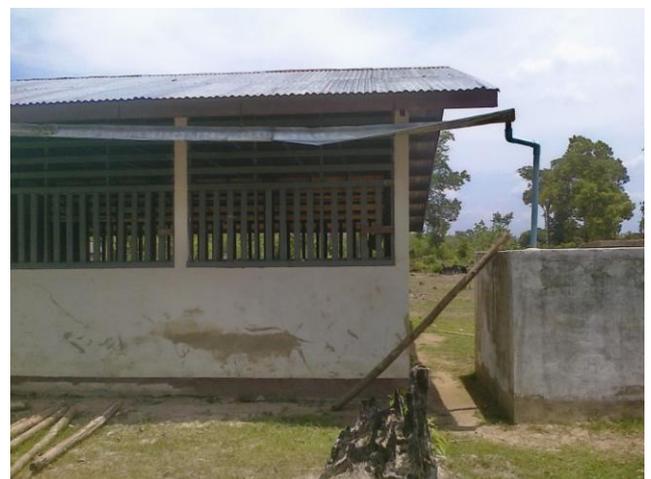
Result of poor roof gutter installation on a four years old school (not SDC built)

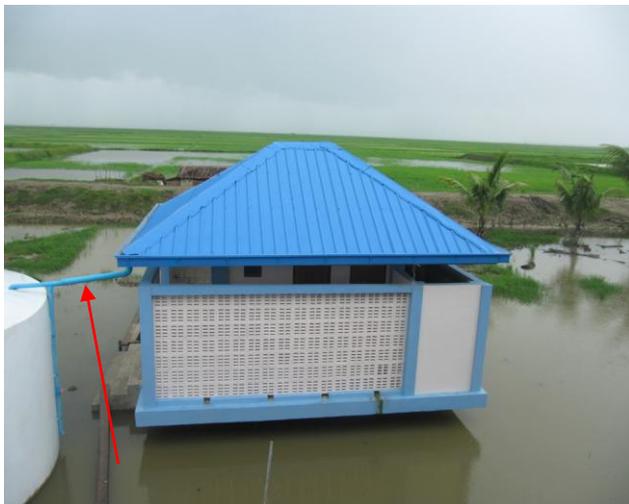
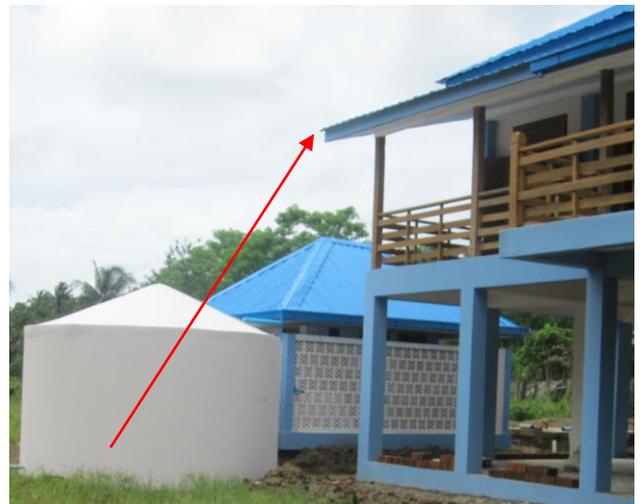
Shortcomings: i) The rainwater tanks (22,7m³) are fed through the relatively small roof of the toilet building instead of the main roof of the school. Hence the potential of a large catchment area is not utilized. ii) The piping of the inlet is weakly done and the outlets are equipped with poor quality of locally made taps. iii) Drinking water system and toilet water have the same source.

Implications if not rectified: The tanks will hardly be filled due to the limited catchment area of the toilet building. The taps, if uncontrolled or left open may drain the tank instantly.

Wrong water source: the small toilet roof feeds the big water tank while the water of the main roof of the school is not utilized

Required improvements: The construction of roof gutters and the installation of a functioning and durable plumbing system require skilled laborers. GI plumbing should be considered. It is highly recommended to provide the toilets and the drinking water system with individual sources: the main roof of the school building should feed the drinking water tank. The toilets should be fed by water collected from the toilet roof and alternative sources such as shallow wells or pumping from nearby ponds for the dry months should be built if required (ref Annex 2). The tanks should – wherever possible – be located in a way that no horizontal piping is required.

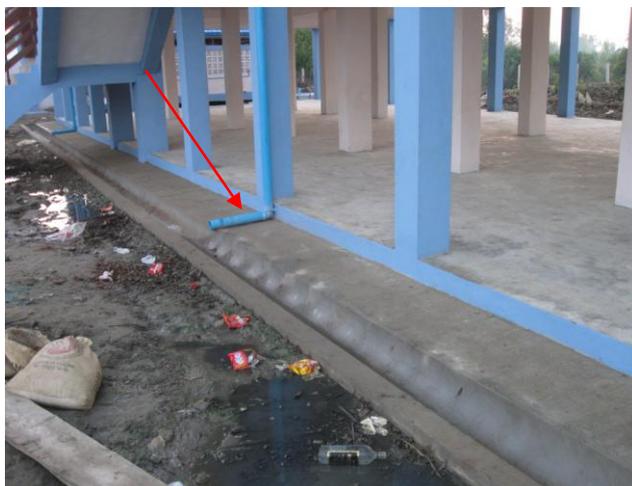
Unprotected plastic pipe, not sustainable

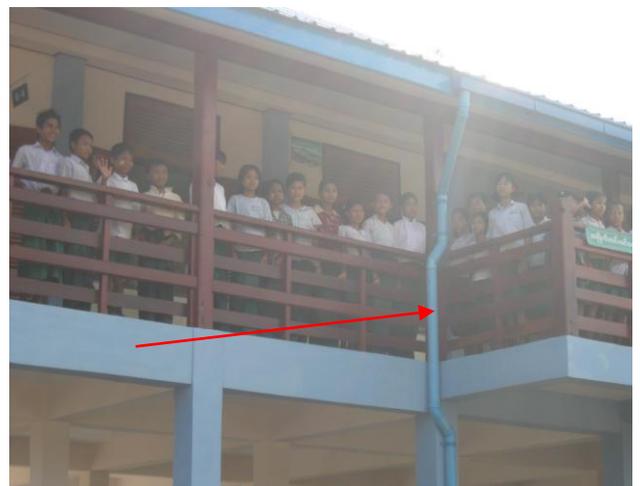
Complicated and expensive downpipe, not necessary, to be replaced by a simple outlet

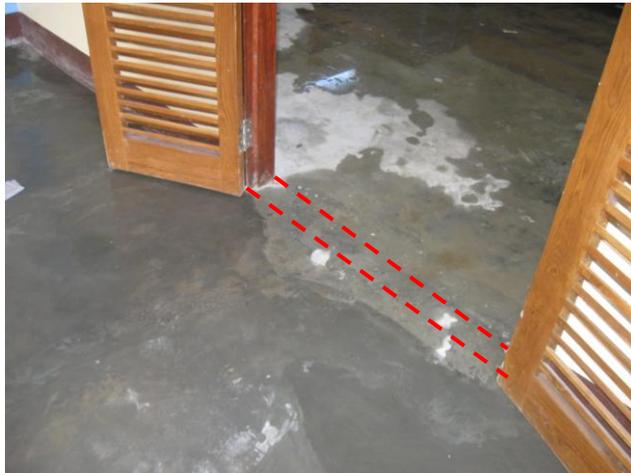
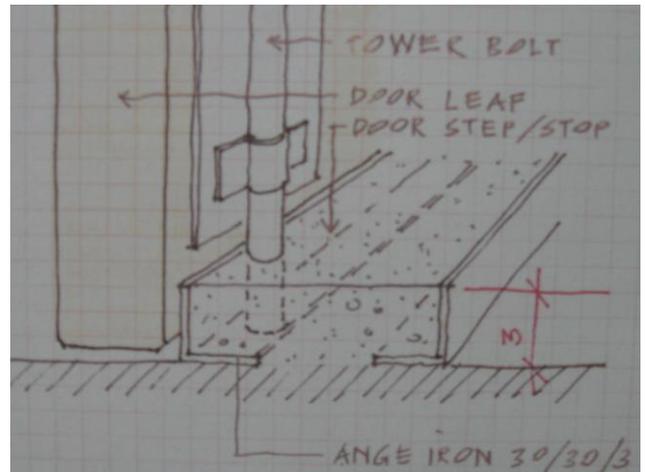
Shortcomings: 1) The double wing door shutters have no proper stop at the bottom. 2) In cases of heavy rains and winds water from the veranda floor might spill into the classrooms.

Implications if not rectified: i) The guide for the tower bolt runner will get loose and the doors cannot be locked safely after some time. ii) No risk of structural or longevity problems.

Required improvements: Through the provision of a doorstep of 3 cm height (30/30/3 mm steel angle) the problems can be eliminated.

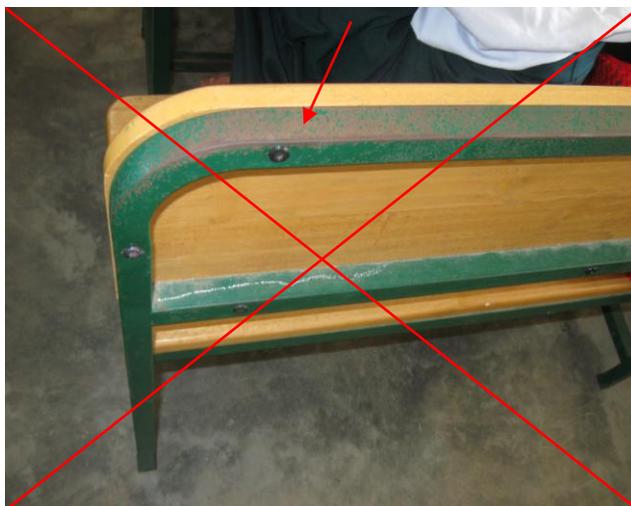
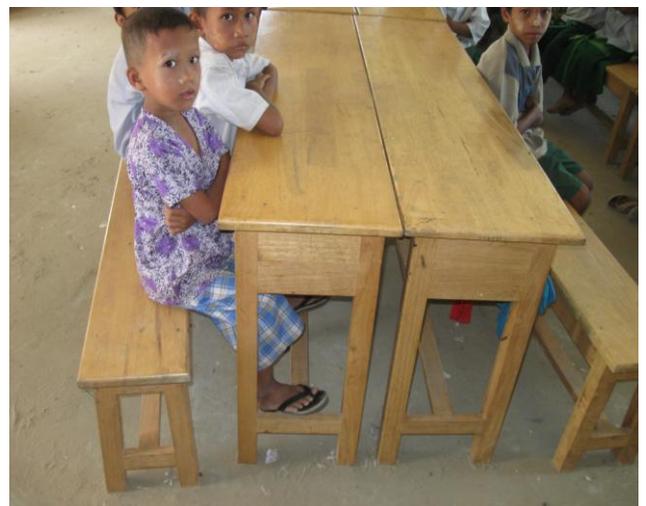
Shortcoming: The frame of the furniture is out of mild steel sprayed with paint. In some cases the paint has already faded away and the steel has become rusty after a few month of use.

Implication if not rectified: The steel frames will become unattractive and deteriorate after a short time.

Required improvement: The use of mild steel (even if persevered) should be avoided wherever possible in the salty air of the delta. In the next phase only wooden furniture should be used.

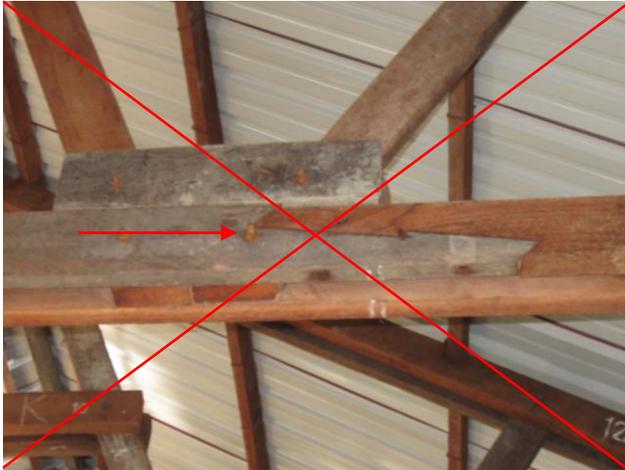
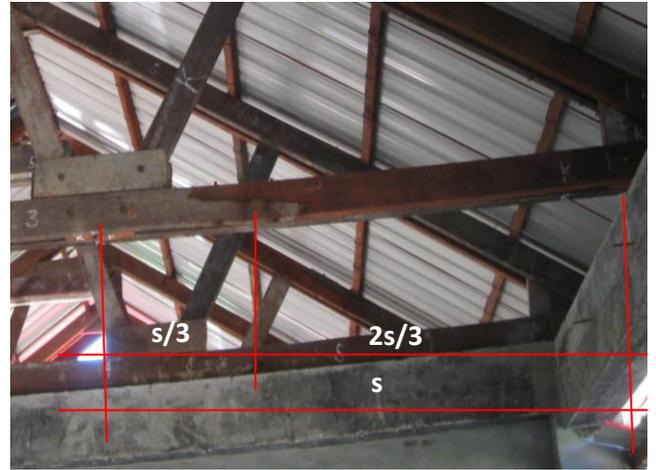
Shortcoming: The joints of the truss members are in some cases not ideally located.

Implication if not rectified: The load bearing capacity of the truss might be reduced.

Required improvement: As a rule of thumb, the joints of the horizontal member should be placed approx $s/3$ away from the diagonal joint.

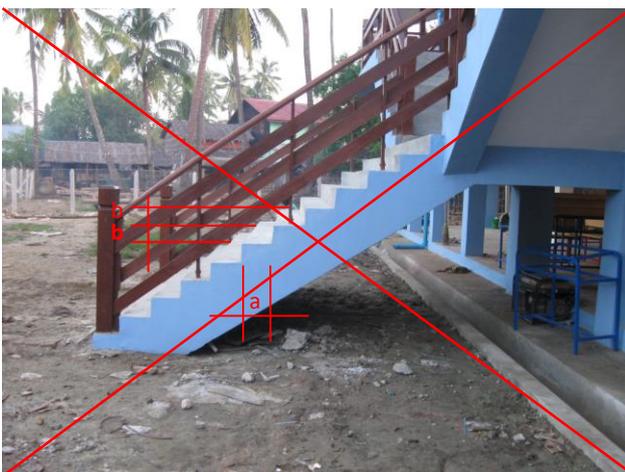
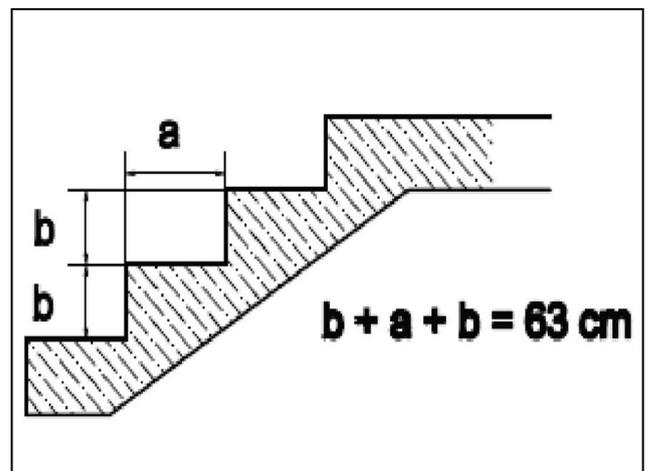
Shortcoming: The staircase is not designed according to common rules. The ratio between riser and tread is not appropriate.

Implication if not rectified: The shortcoming has no implication, the stairs are just uneasy to use.

Existing: $a = 23 \text{ cm}$, $b = 14 \text{ cm}$ $\rightarrow 23 + 14 + 14 = 51 \text{ cm}$!

Required improvement: The sum of the dimensions of two risers and one tread should be 60 – 65 cm, and the minimum dimension for the tread is 25. The steps of the stairs have to be re-designed. No change of the foundation is required.

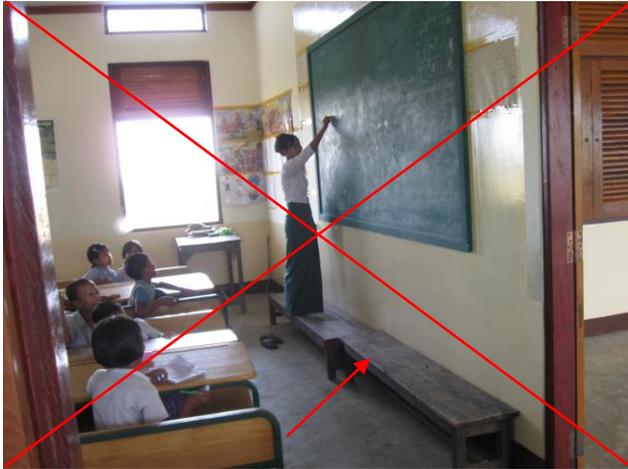
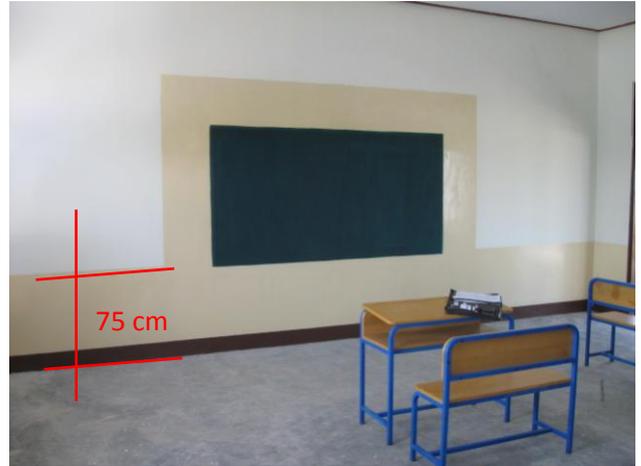
Shortcoming: The green board is not conveniently placed. Teachers need a step to utilize the whole board properly. Students can only use the lower part of it.

Implication if not rectified: No implication, just inconvenient.

Required improvement: Place the green board in future schools at a height between 75 to 175 cm above floor level.

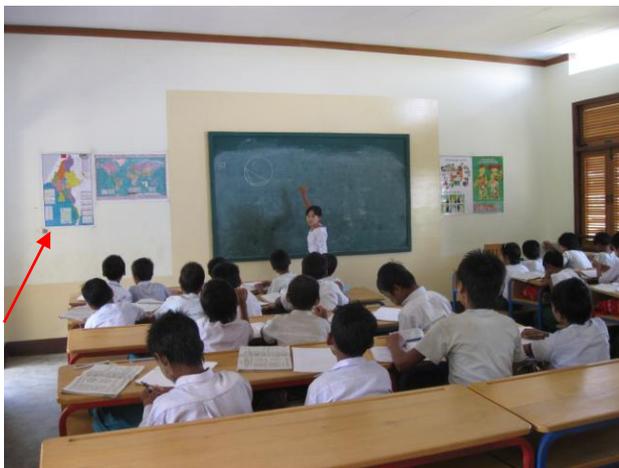
Shortcoming: The cement plaster of the classrooms walls does not allow an easy pinning up of posters and drawings, pictures, etc.

Implication if not rectified: White wash of the walls will peel off due to use of cello tape.

Posters fixed with cello tapes on the wall plaster create ugly stains on the whitewash

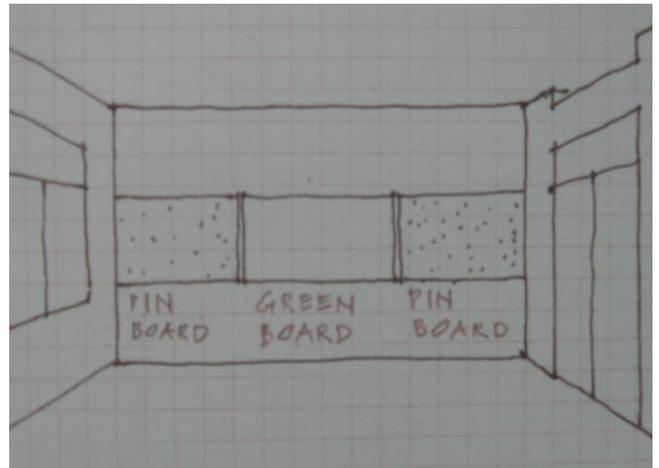
Pin boards on both sides of the green board (out of plywood or cork sheeting)

Required improvement: Install Pin Boards (enamel painted plywood or particle board) at the front wall of the classroom to make the fixing of posters easy.

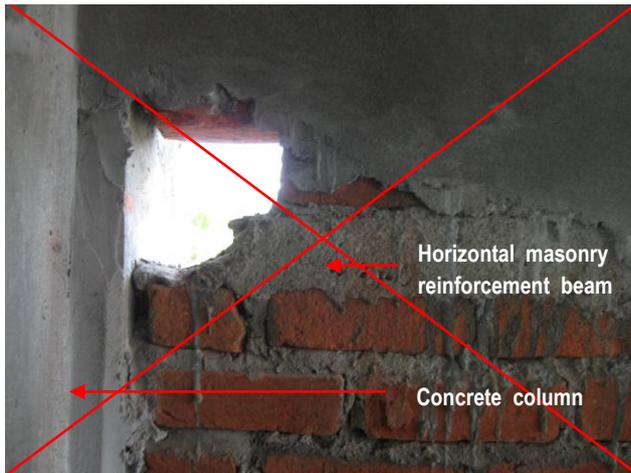
Shortcoming: In some cases the wall reinforcement beam at mid height of the walls is not connected to the concrete columns.

Implication if not rectified: There is a risk of cracks occurring in the masonry walls. Earthquake resistance is reduced.

In some cases the masonry reinforcement beam not connected to column

Required improvement: Make sure that all the wall reinforcement is properly connected to the concrete columns. This detail must be visible on the working drawings.

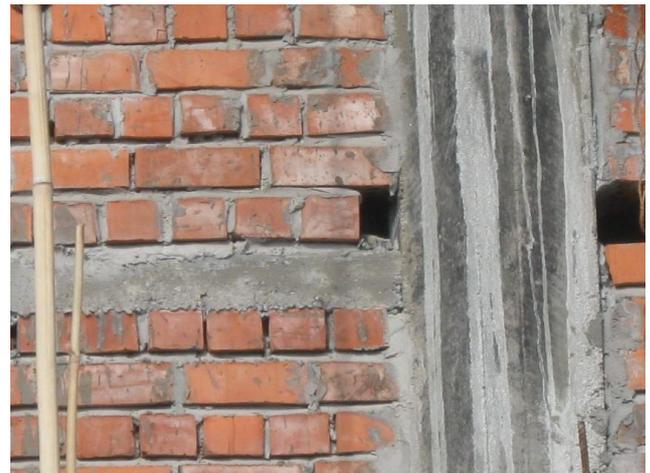
Correct connection between masonry reinforcement and column

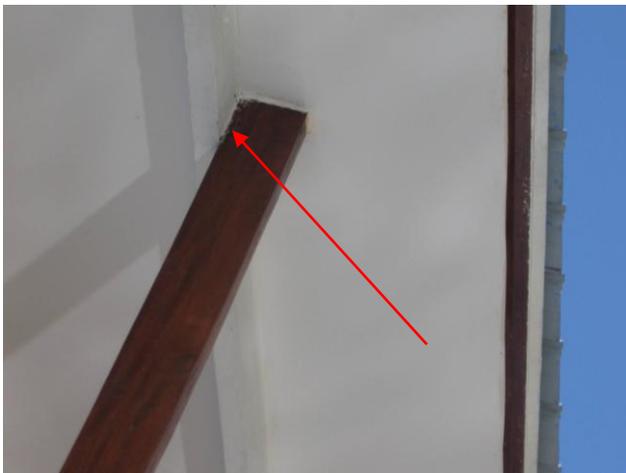
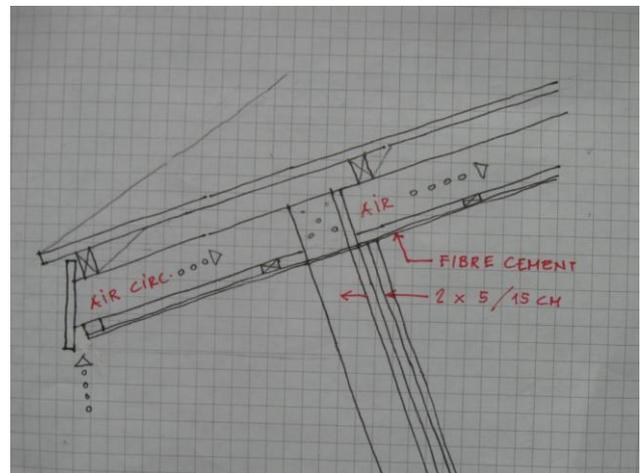
Shortcoming: The purlin is fixed to the stand only by one bolt.

Implication if not rectified: The load bearing capacity of the structural frame is not utilized.

Required improvement: Replace single stand by a twin post and simplify roof structure as per the below sketch.

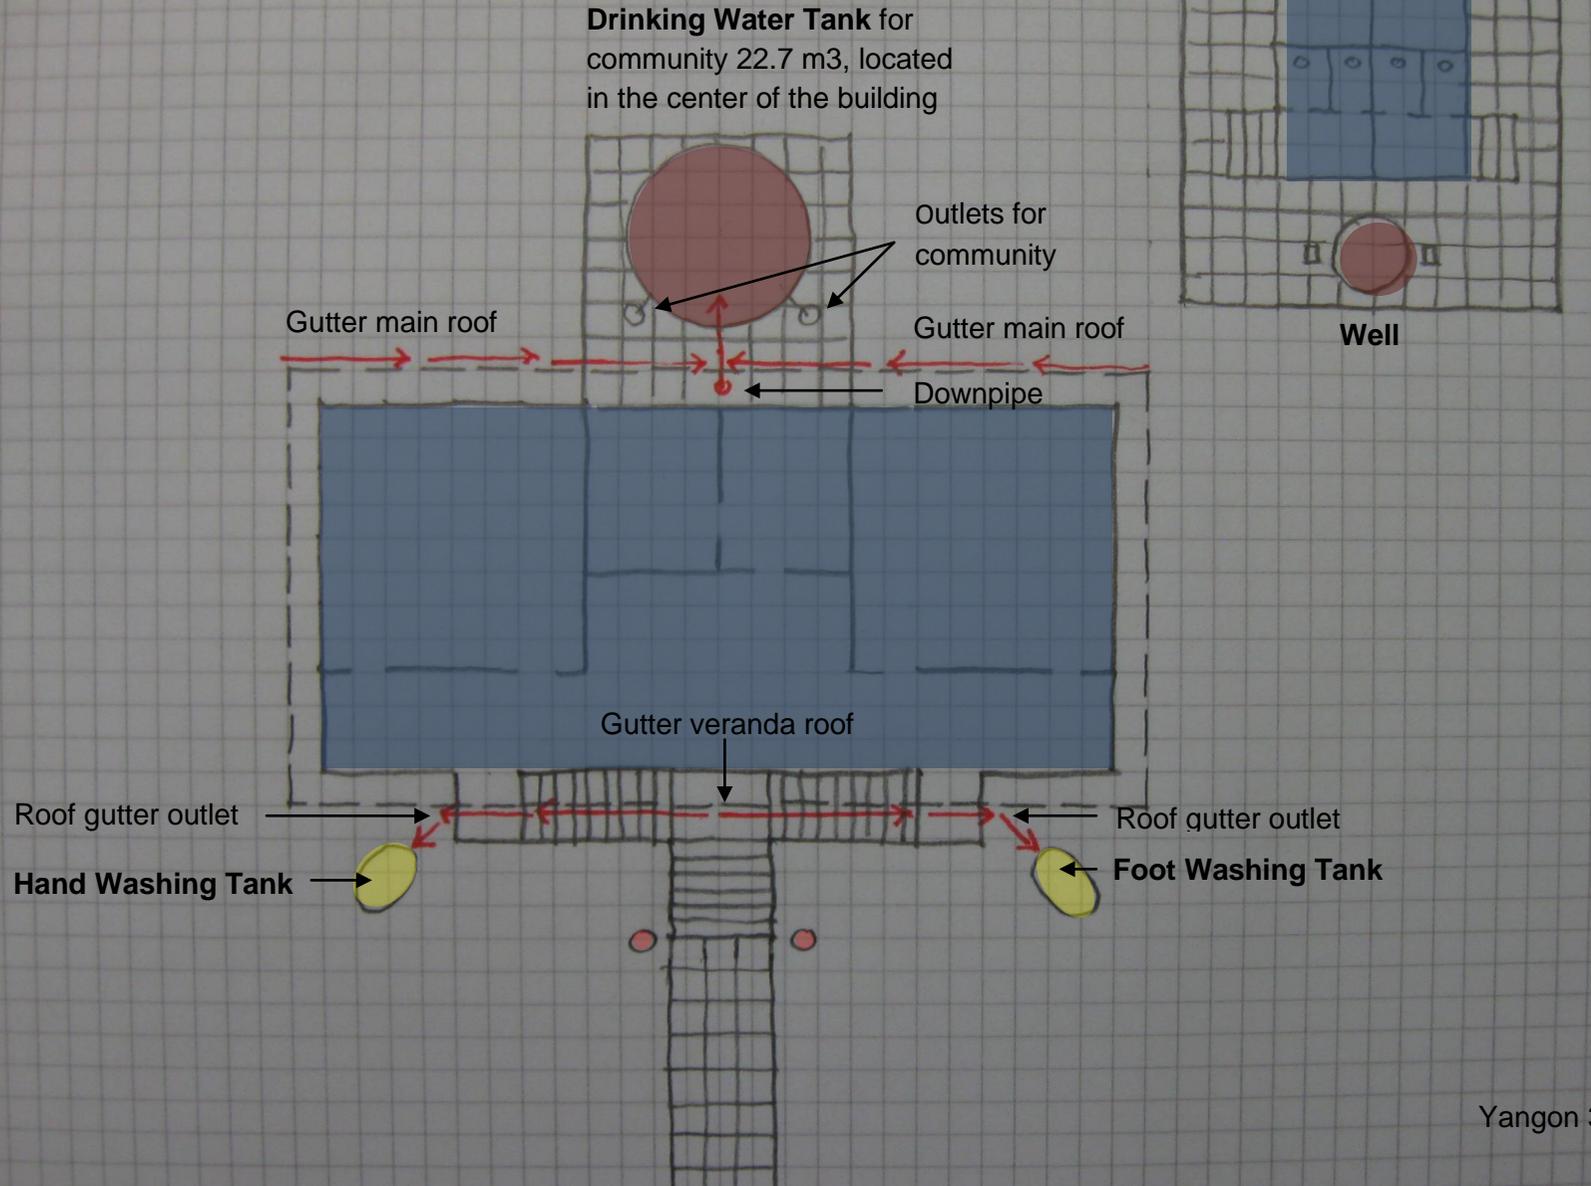
Annex 3

Scheme Rainwater Harvesting System

The WatSan component requires a re-design. The toilet design prepared by the national consultant is not sustainable and does not withstand in-depth cost/benefit considerations. In agreement and consultations with the project team, DS has developed a new design scheme in which drinking water and toilet water is clearly separated. Plumbing is reduced to a minimum and the sanitary apparatus are familiar in rural areas. The revised design scheme of the WatSan-Unit is attached in Annex 2. A scheme of rainwater harvesting system is reflected in Annex 3.
