Retrofitting of the **HRC Office Battagram**

The building in Battagram that SDC selected as Housing Reconstruction Center (HRC) has been constructed 1950 in colonial style. The house has been partially damaged through the October 05 earthquake. The concrete lintels above windows and doors broke. In addition the center wall cracked seriously.

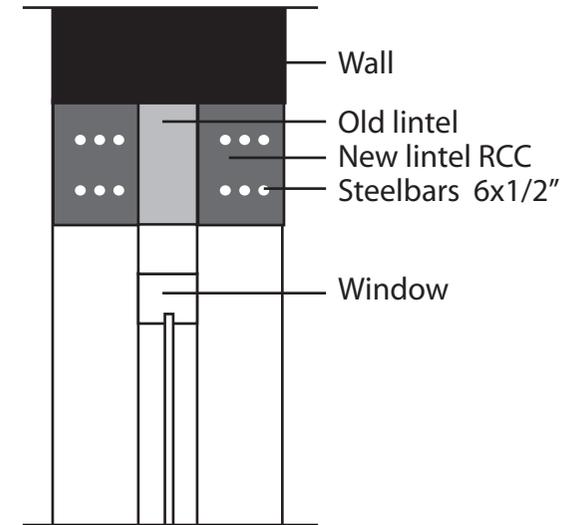
Replaced lintels above door and window

Most of the lintels were broken in the earthquake. The lintels have been replaced in two parts, from both side of the wall.
