Project name

Country	Viet Nam
Region/town	Xuan Quang 2 commune, Dong Xuan District, Phu Yen province
GIS data (WGS 84)	
Project type	Post-disaster Reconstruction
Typology	Individual housing
Approach	Self-help / contracted construction teams from the local area
Beneficiaries	Local population affected by typhoon Ketsana in 2009
Climate	Tropical / coastal
Special constraint	Storm / flood
start / end of project	15.06.2010 – 30.09.2010
Country GNP	USD / cap 650 in 2005

Organization (donor)	Swiss Red Cross (Swiss Solidarity)
IO/NGO partners	Vietnam Red Cross (VNRC)
GO partners	Xuan Quang 2 Commune Authority, Dong Xuan District

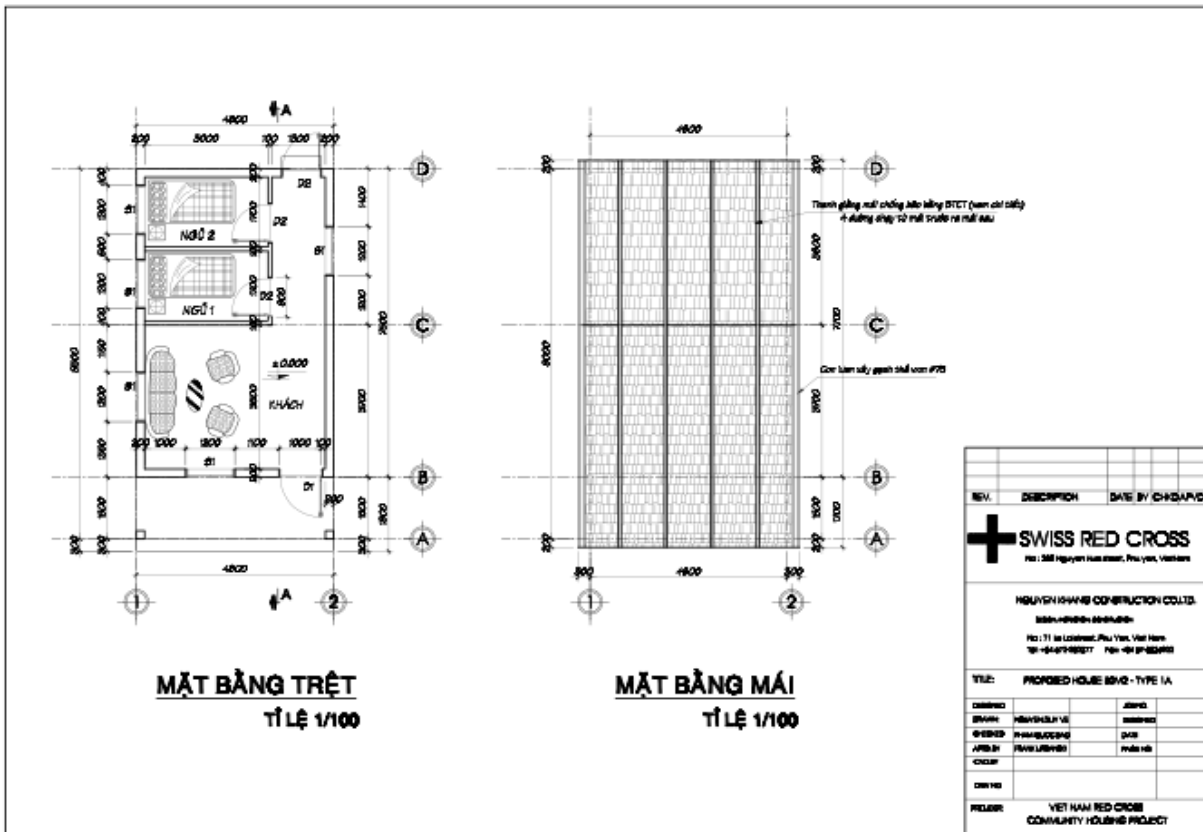
BẢNG THỐNG KÊ THÉP

Structure	Foundations	Rock foundation with foundation bracing beam
	Walls or columns	Double brick wall
	Facade	Plastered and painted
	Roof	Wooden tiled roof
	typhoon protection	The roof connected to the wall bracing beam. Four small beams hold the tiles firmly.
materials	Floor surface	Paved with ceramic tile
	Walls	Outside wall constructed with double brick, inside wall with single brick
	Doors	Glass metal door
	Windows	Glass metal window
	Ceiling	No ceiling available, done later by beneficiaries
	Thermo insulation	No
	Roofing	Clay Tiles on wooden structure
WatSan	Water	Funded by Vietnamese Government
	Toilets	Funded by Vietnamese Government
	Waste water	Soak pits provided in individual plots
	Rain water	No
equipment	Heating system	No
	Electricity connection	Connected by beneficiaries
	Telephone connection	No connection
	Cooking facilities	Funded by Vietnamese Government
